# **2021 PAVEMENT CONDITION INDEX (PCI) REPORT**

**Report Submitted to:  
Jacobs Engineering  
Group, Inc.**

**December 2023**

***Lincoln Park Airport (N07)  
Lincoln Park, Morris County, New Jersey***

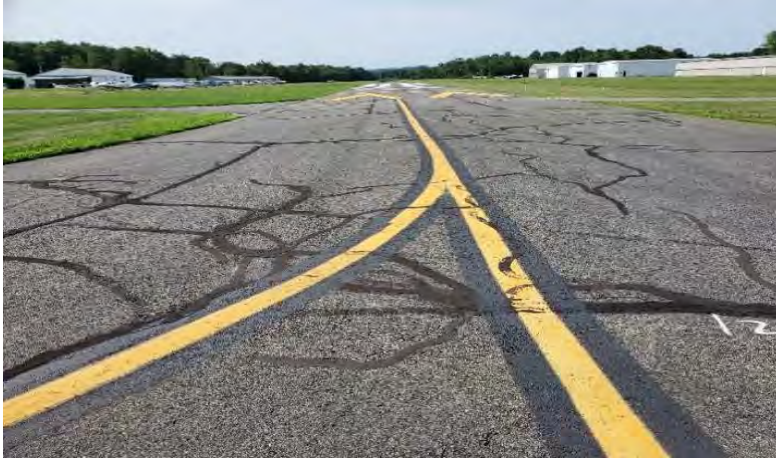
**Photo No: A-1**

Description: L/M-Block Cracking; M-Weathering

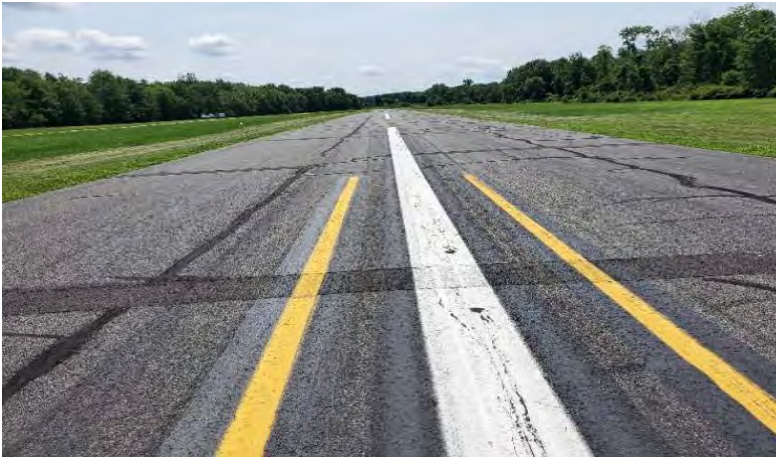
**Photo No: A-2**

Description: L/M-Longitudinal & Transverse Cracking; L-Patching; L/M-Weathering

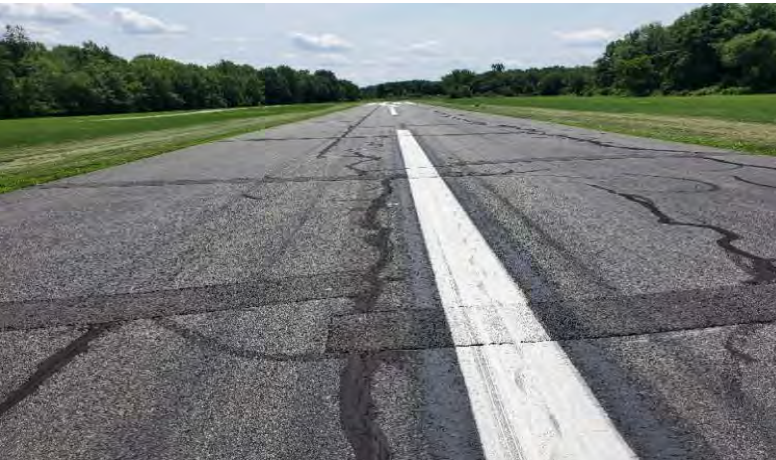
**Photo No: A-3**

Description: L/M-Longitudinal & Transverse Cracking; L-Patching; L/M-Weathering

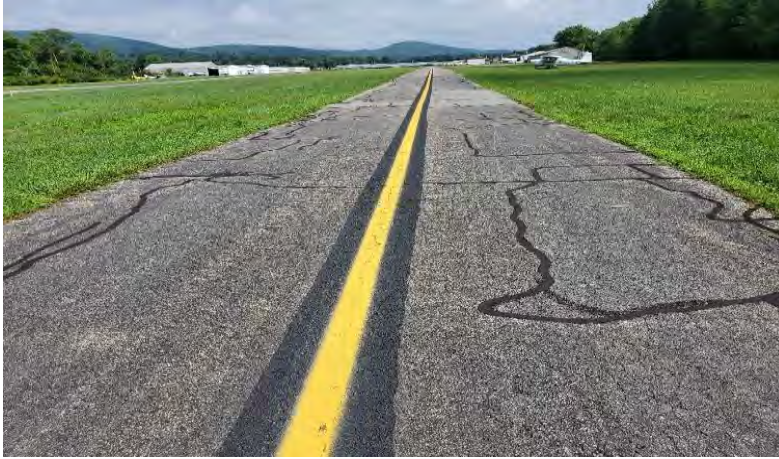
**Photo No: A-4**

Description: L/M-Alligator Cracking; L-Block Cracking; M-Longitudinal & Transverse Cracking; L-Weathering

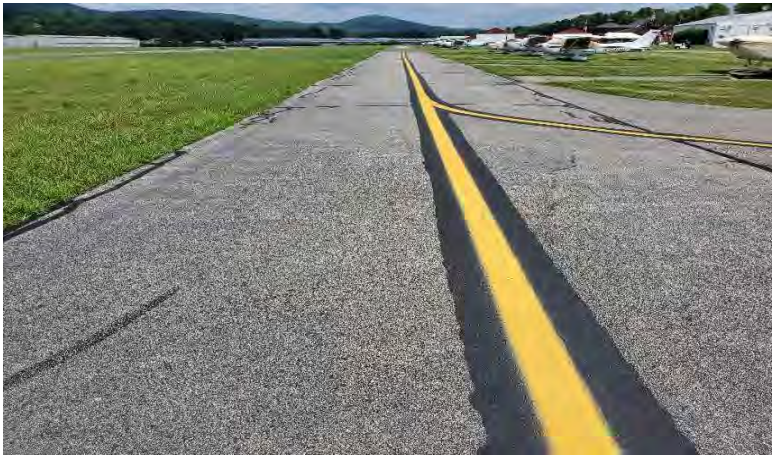
**Photo No: A-5**

Description: L-Longitudinal & Transverse Cracking; L-Weathering

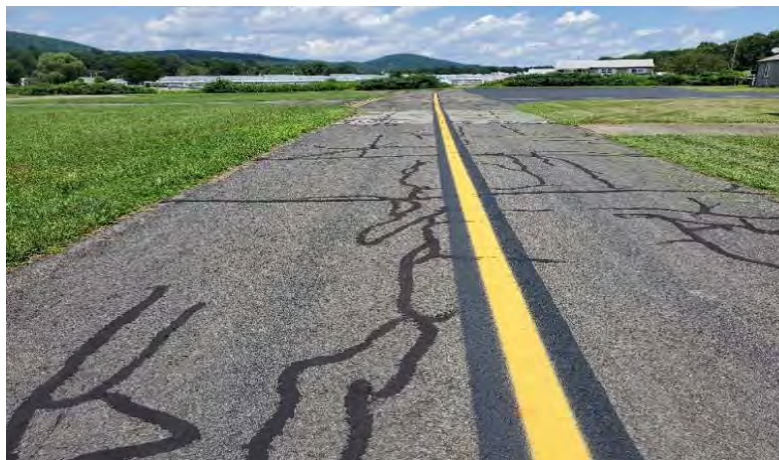
**Photo No: A-6**

Description: L/M-Block Cracking; M-Weathering

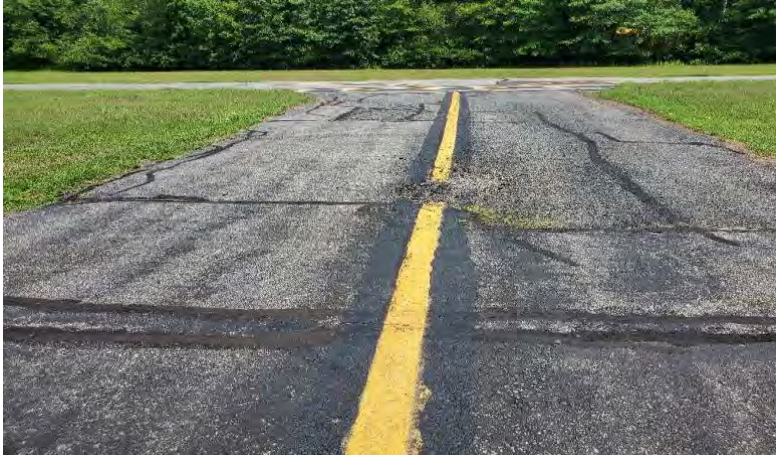
**Photo No: A-7**

Description: L/M-Longitudinal & Transverse Cracking; M-Patching; M/H-Raveling; M-Weathering

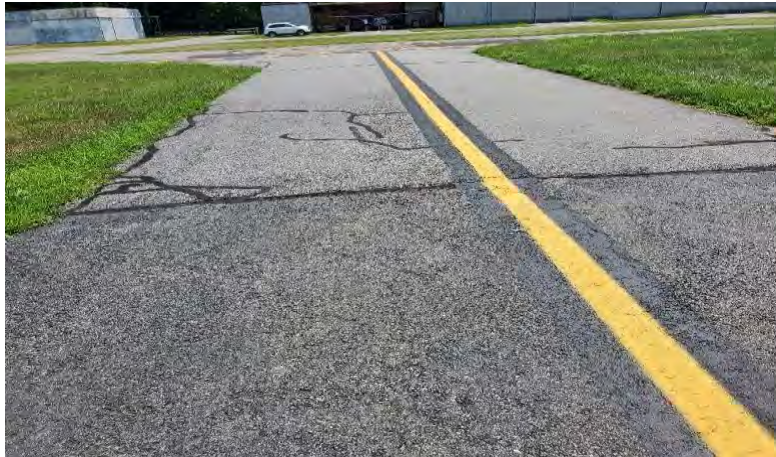
**Photo No: A-7**

Description: L/M-Longitudinal & Transverse Cracking; L-Patching; L-Weathering

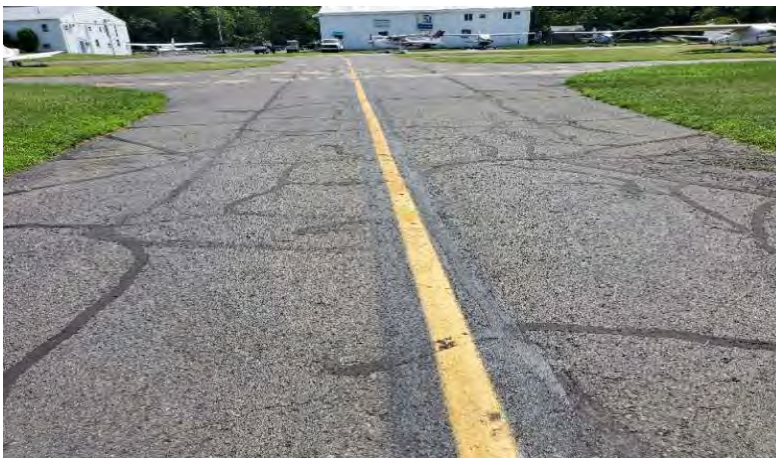
**Photo No: A-9**

Description: M-Block Cracking; M-Raveling; H-Patching; L-Weathering

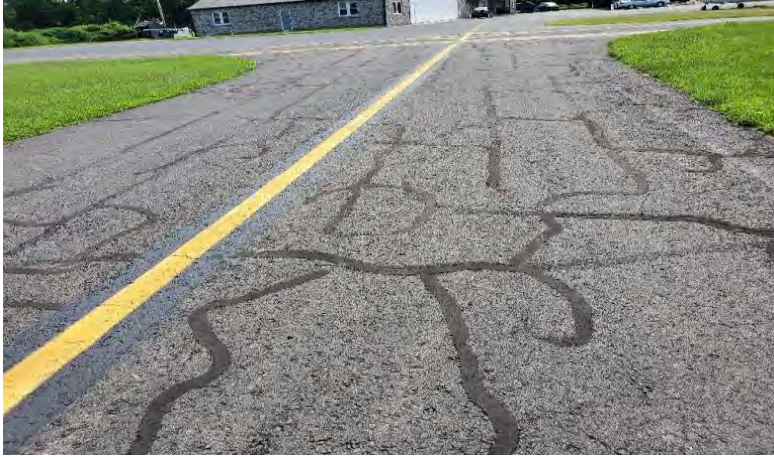
**Photo No: A-10**

Description: M-Block Cracking; M-Weathering

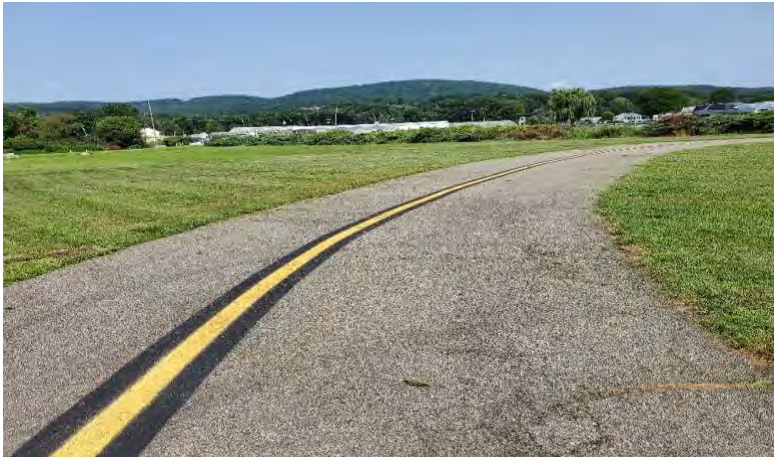
**Photo No: A-11**

Description: M-Longitudinal & Transverse Cracking; M-Alligator Cracking; L-Weathering

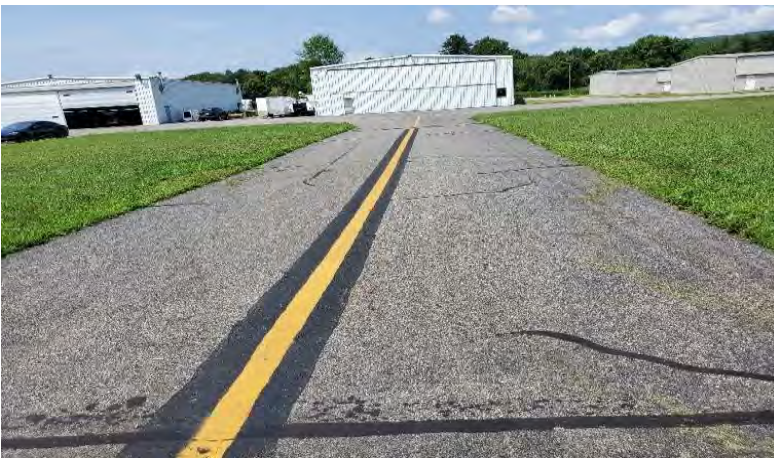
**Photo No: A-12**

Description: L-Longitudinal & Transverse Cracking; L-Weathering

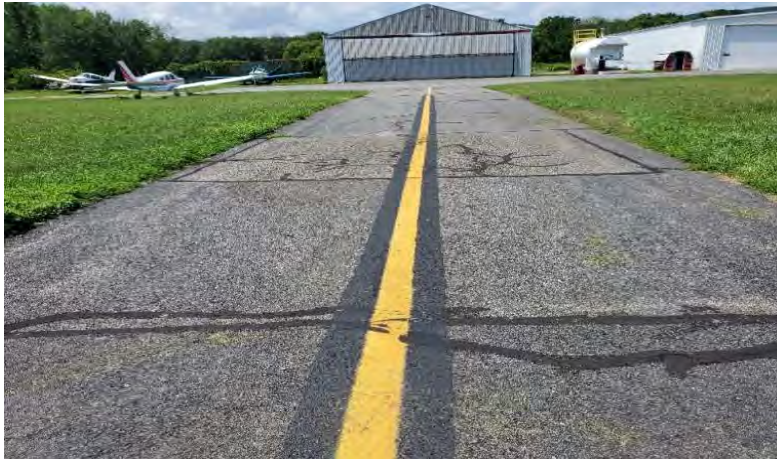
**Photo No: A-13**

Description: L/M-Longitudinal & Transverse Cracking; M-Patching; M-Weathering

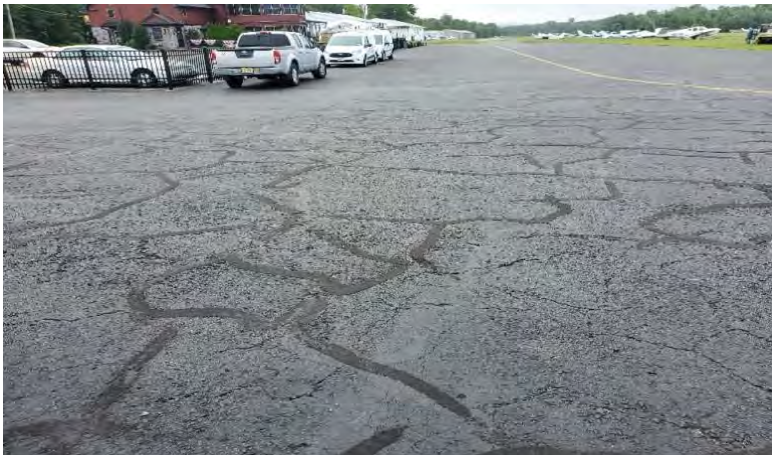
**Photo No: A-14**

Description: M-Block Cracking; L-Raveling

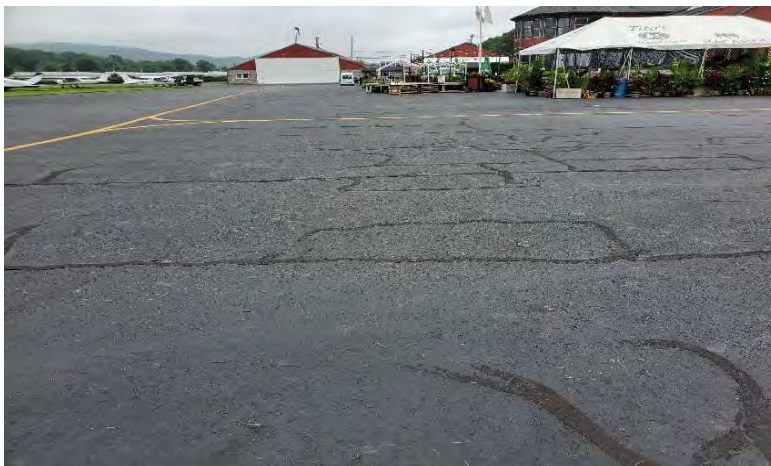
**Photo No: A-15**

Description: M-Block Cracking; M-Longitudinal & Transverse Cracking
