# **2021 PAVEMENT CONDITION INDEX (PCI) REPORT**

**Report Submitted to:  
Jacobs Engineering  
Group, Inc.**

**December 2023**

***Hammonton Municipal Airport (N81)  
Hammonton, Atlantic County, New Jersey***

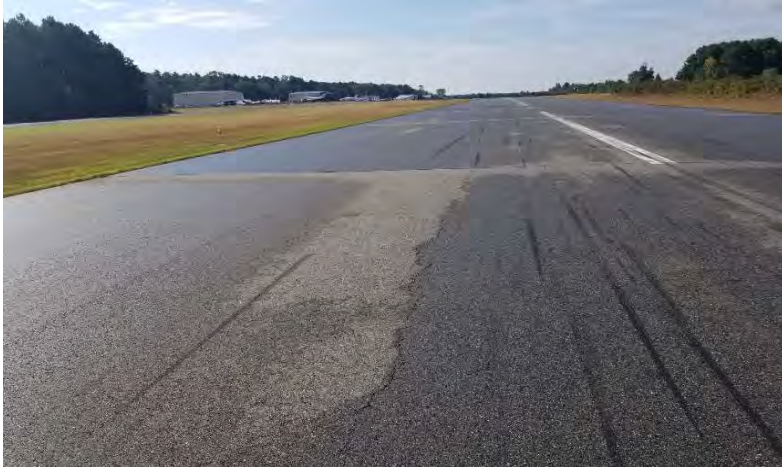
**Photo No: A-1**

Description: L/M-Longitudinal & Transverse Cracking; L-Weathering

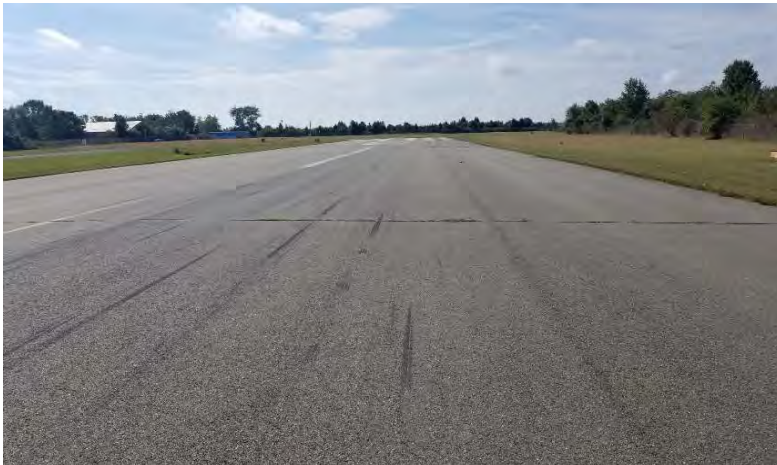
**Photo No: A-2**

Description: M-Transverse Cracking; L-Weathering

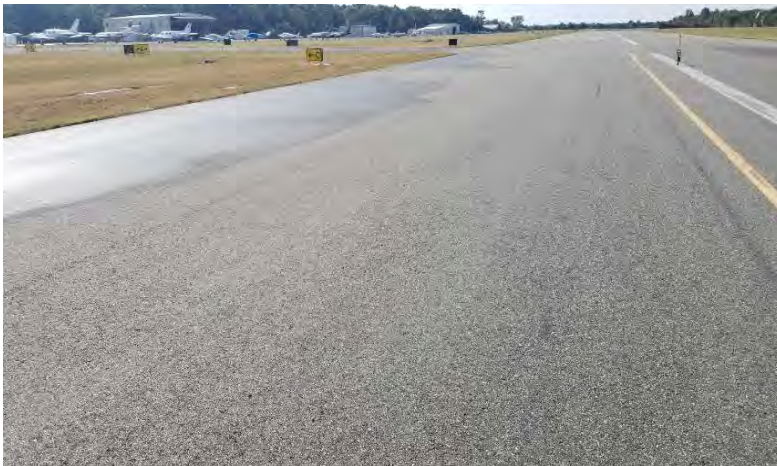
**Photo No: A-3**

Description: L-Weathering

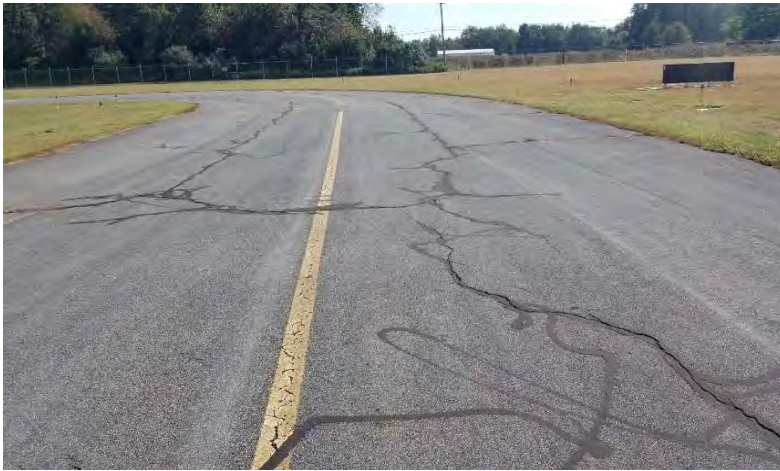
**Photo No: A-4**

Description: L/M-Longitudinal & Transverse Cracking; L-Weathering

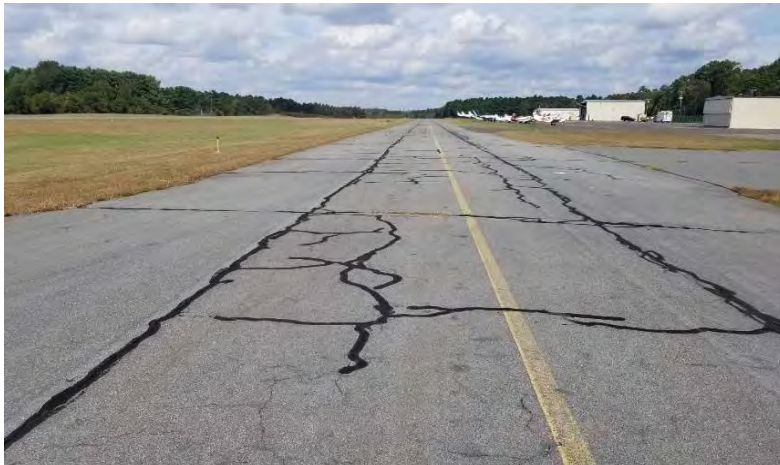
**Photo No: A-5**

Description: M-Block Cracking; L-Longitudinal & Transverse Cracking; L-Weathering

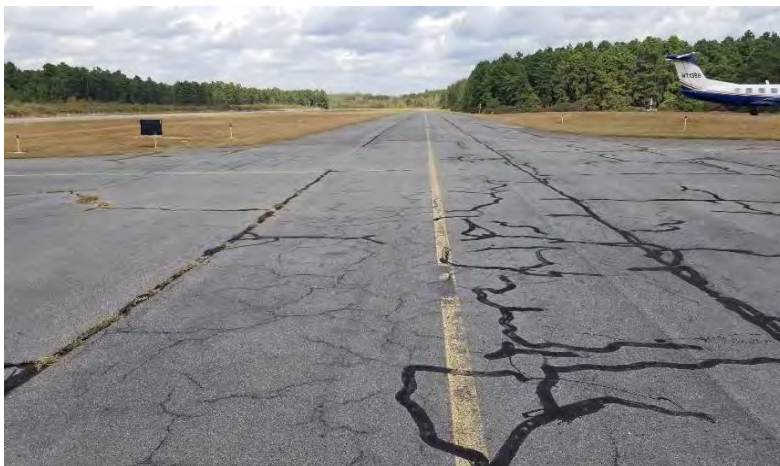
**Photo No: A-6**

Description: M-Block Cracking; L-Weathering

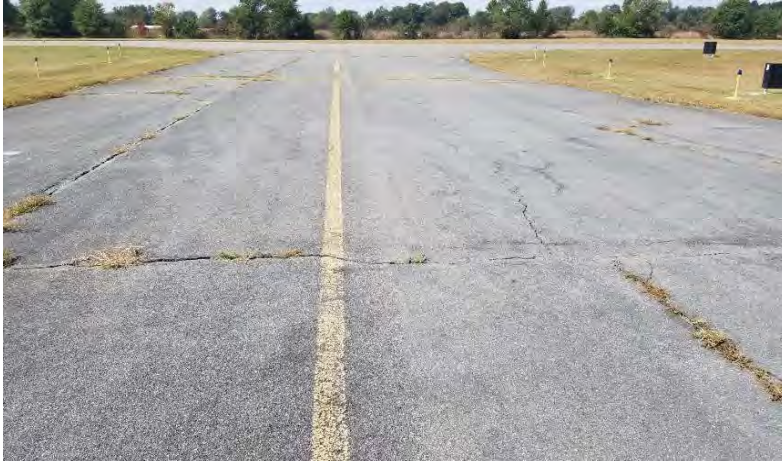
**Photo No: A-7**

**Description: M/H-Longitudinal & Transverse Cracking; L-Weathering**

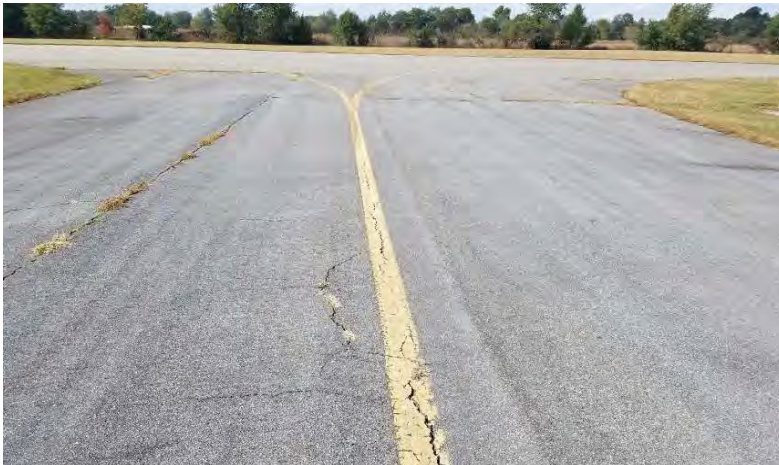
**Photo No: A-8**

**Description: M/H-Longitudinal Cracking; L-Weathering**

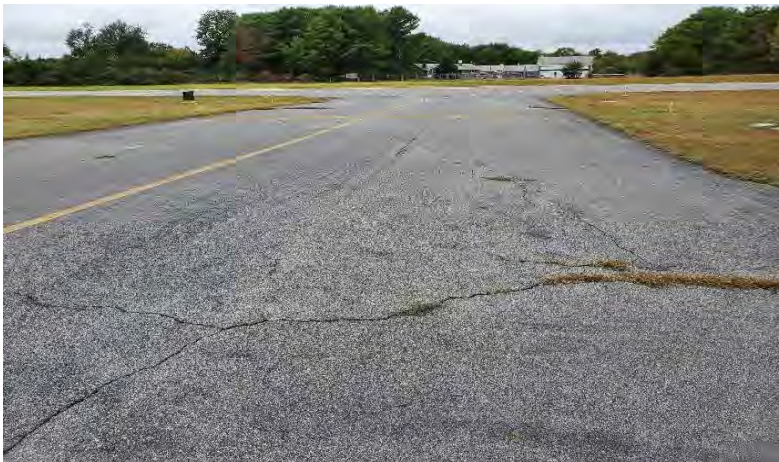
**Photo No: A-9**

**Description: M-Longitudinal & Transverse Cracking; L-Weathering**

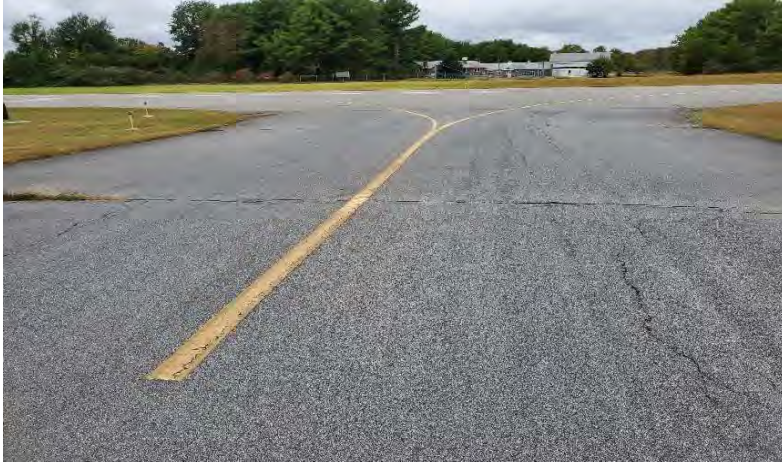
**Photo No: A-10**

Description: M/H-Longitudinal & Transverse Cracking; L-Weathering

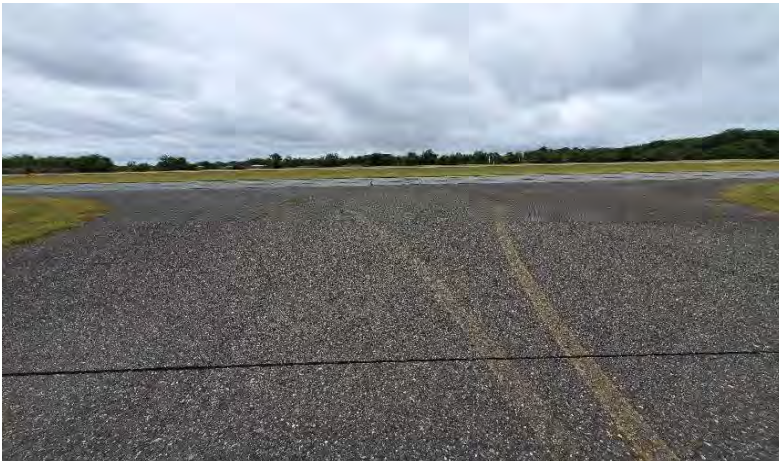
**Photo No: A-11**

Description: M-Longitudinal & Transverse Cracking; M-Weathering

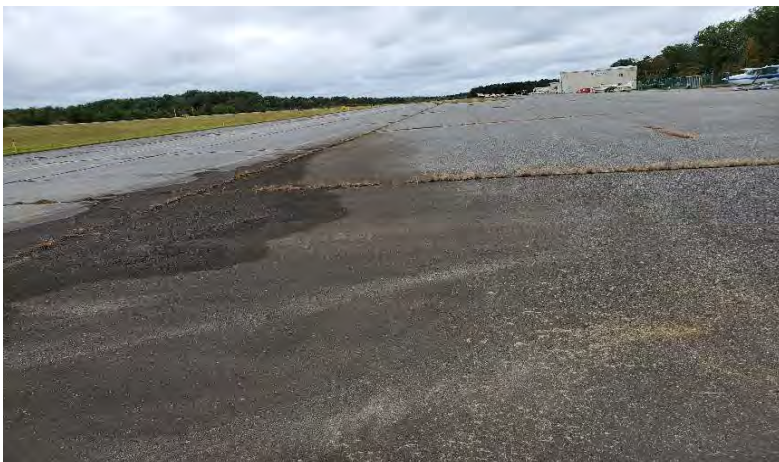
**Photo No: A-12**

Description: M/H-Longitudinal & Transverse Cracking; L/M-Weathering

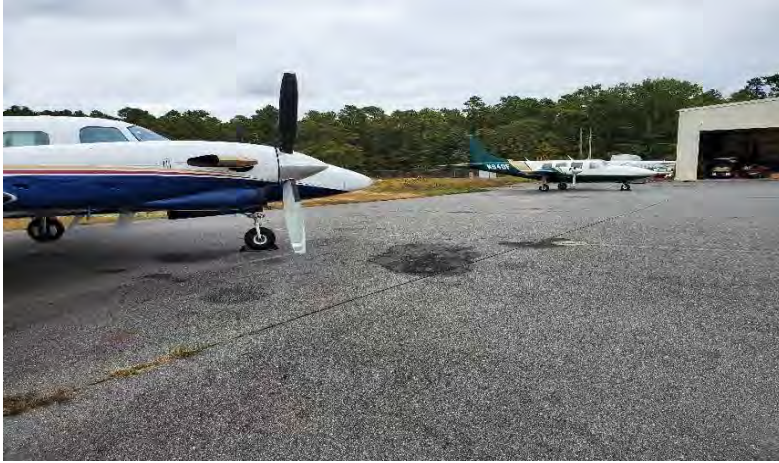
**Photo No: A-13**

**Description: Oil Spillage; M-Longitudinal & Transverse Cracking**

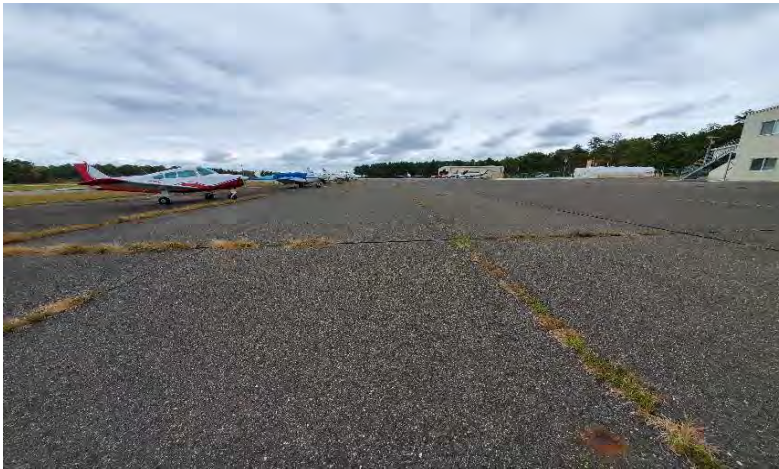
**Photo No: A-14**

**Description: M-Longitudinal & Transverse Cracking; L/M-Weathering**
