**Advanced Infrastructure  
Design, Inc.**

**2021  
PAVEMENT CONDITION INDEX  
(PCI) REPORT**

**December 2023**

***Somerset Airport (SMQ)  
Bedminster Township, Somerset County, New Jersey***

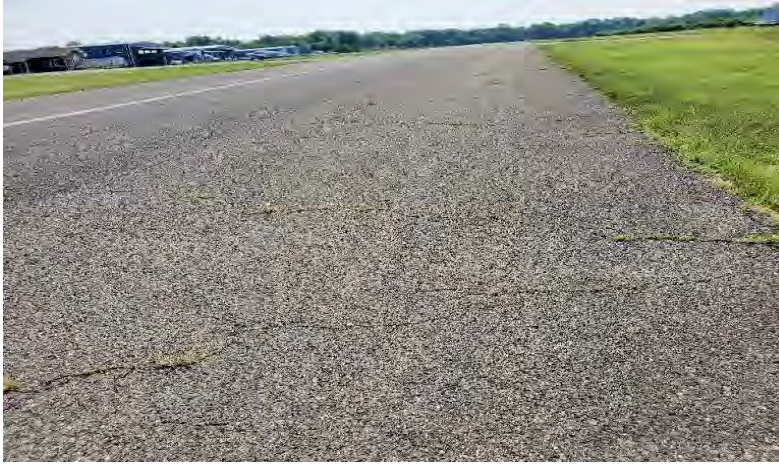
**Photo No: A-1**

Description: M-Block Cracking; M-Weathering

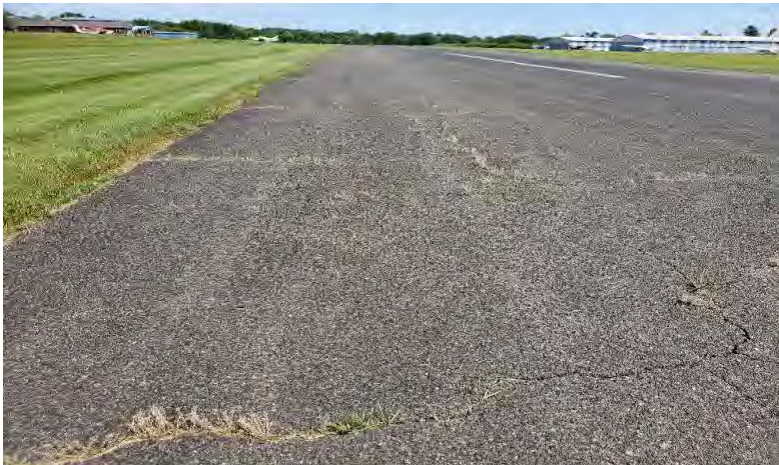
**Photo No: A-2**

Description: M-Block Cracking; M-Weathering

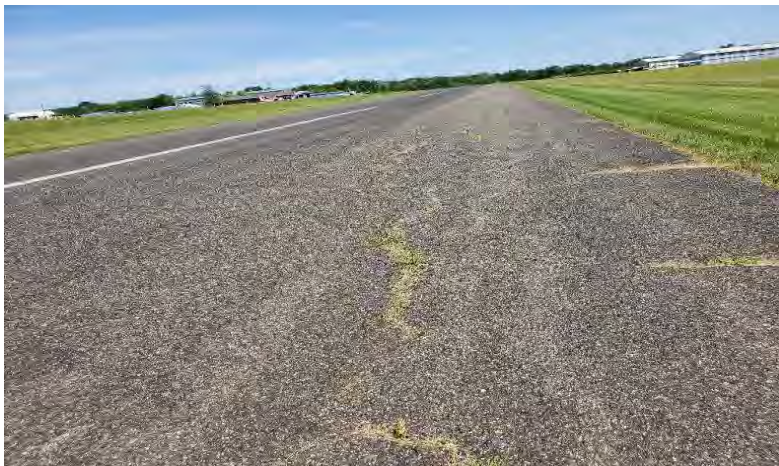
**Photo No: A-3**

Description: M-Block Cracking; M-Weathering

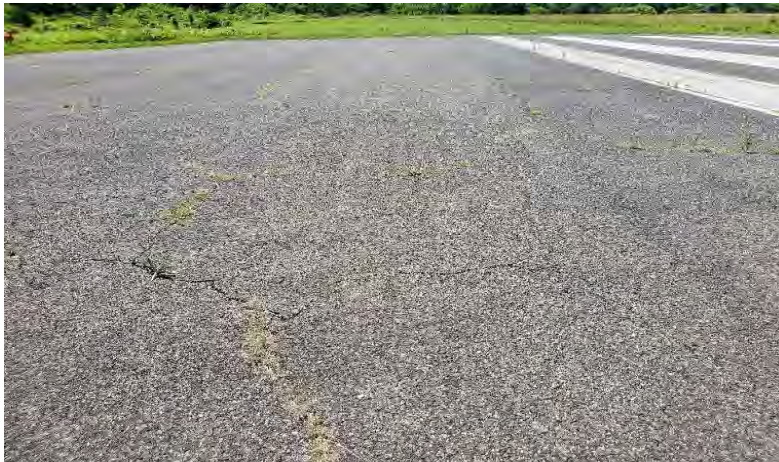
**Photo No: A-4**

Description: M-Block Cracking; M-Weathering

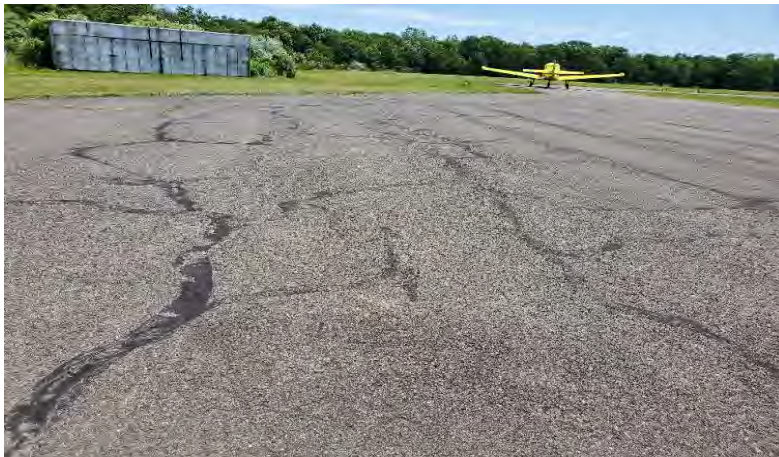
**Photo No: A-5**

Description: L/M-Block Cracking; M-Weathering

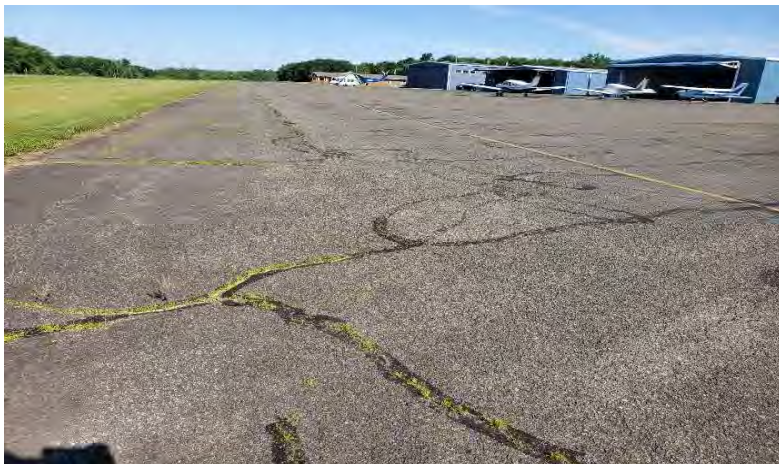
**Photo No: A-6**

Description: M-Block Cracking; M-Weathering

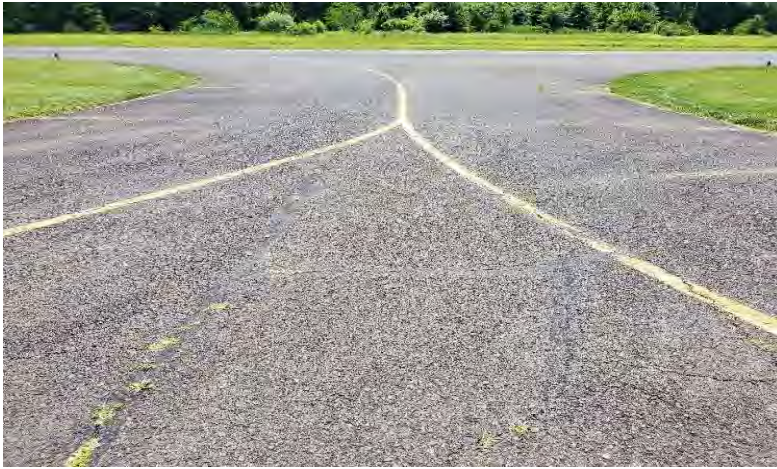
**Photo No: A-7**

Description: M-Block Cracking; M-Weathering

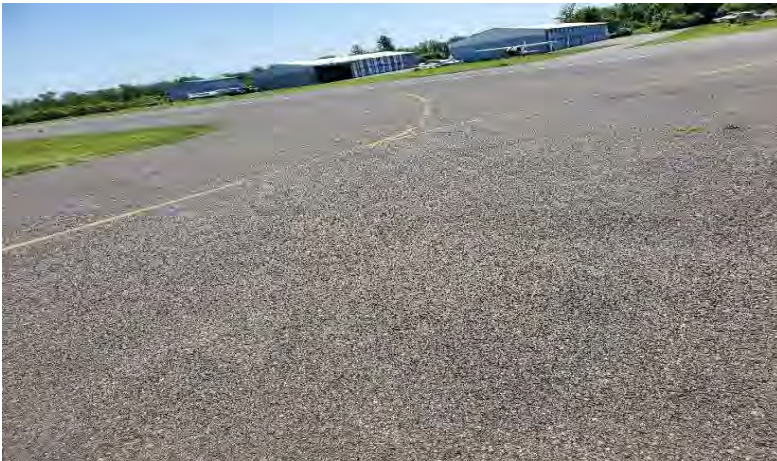
**Photo No: A-8**

Description: L/M-Block Cracking; M-Weathering

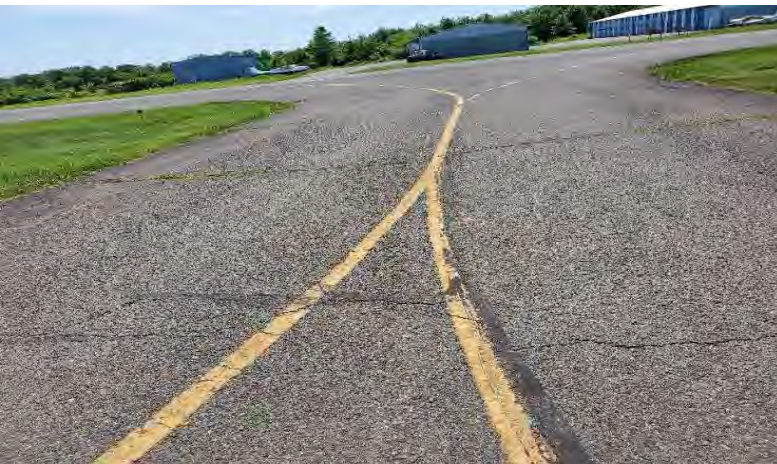
**Photo No: A-9**

Description: M-Longitudinal & Transverse Cracking; M-Weathering

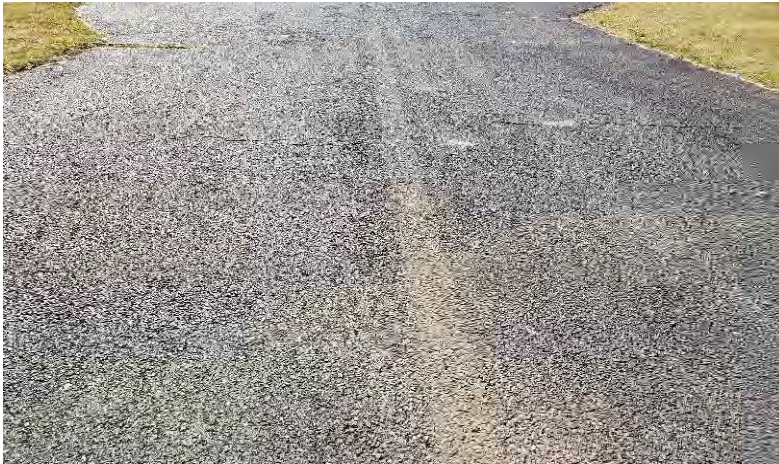
**Photo No: A-8**

Description: L/M-Longitudinal & Transverse Cracking; L/M-Weathering

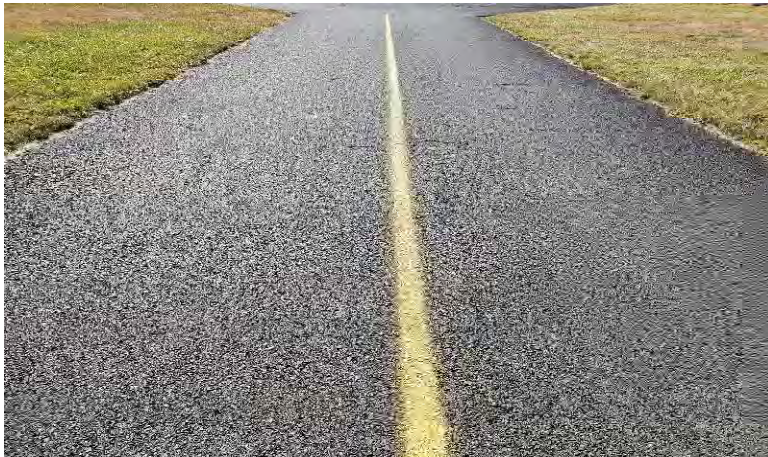
**Photo No: A-9**

Description: L/M-Longitudinal & Transverse Cracking; L/M-Weathering

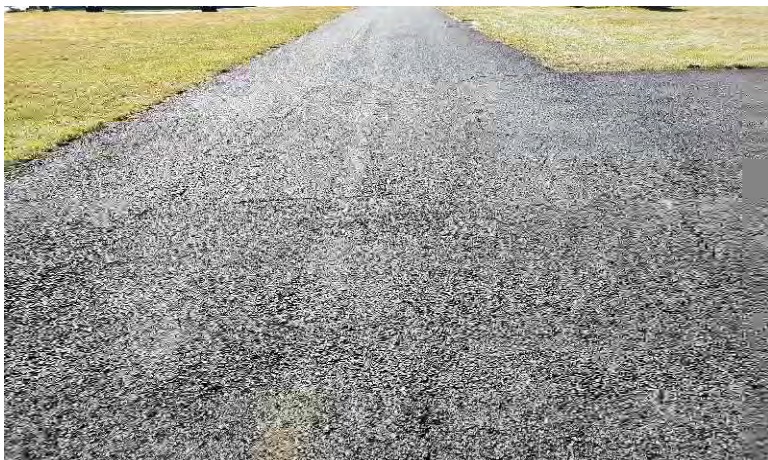
**Photo No: A-10**

Description: L/M-Longitudinal & Transverse Cracking; L-Weathering

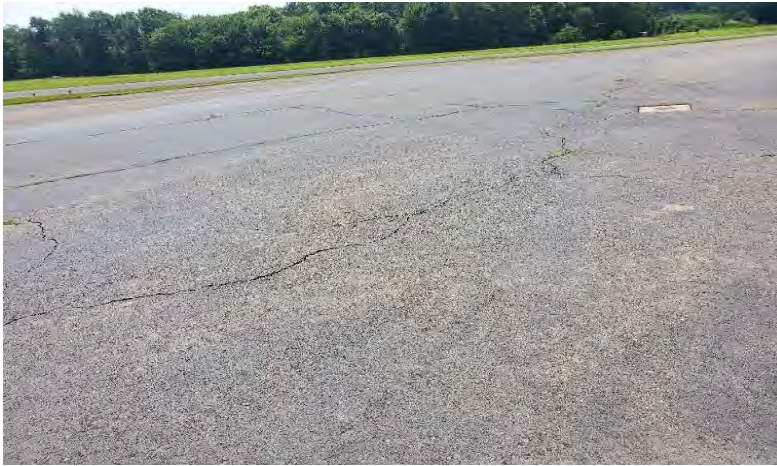
**Photo No: A-10**

Description: M-Block Cracking; L-Patching; M-Weathering

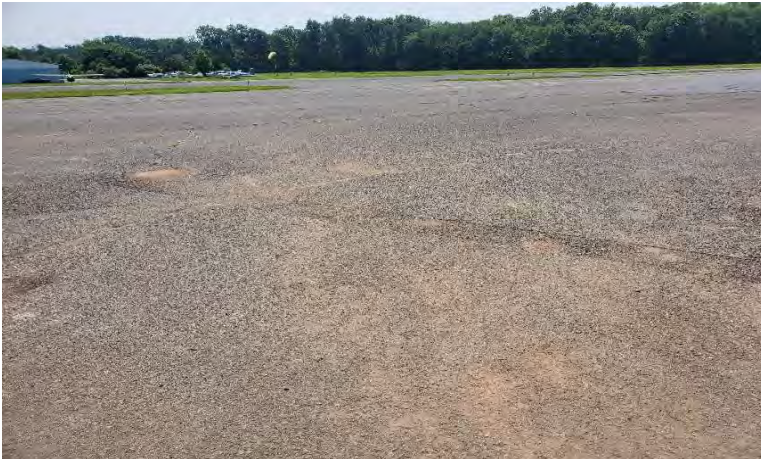
**Photo No: A-9**

Description: L/M-Patching; M-Weathering

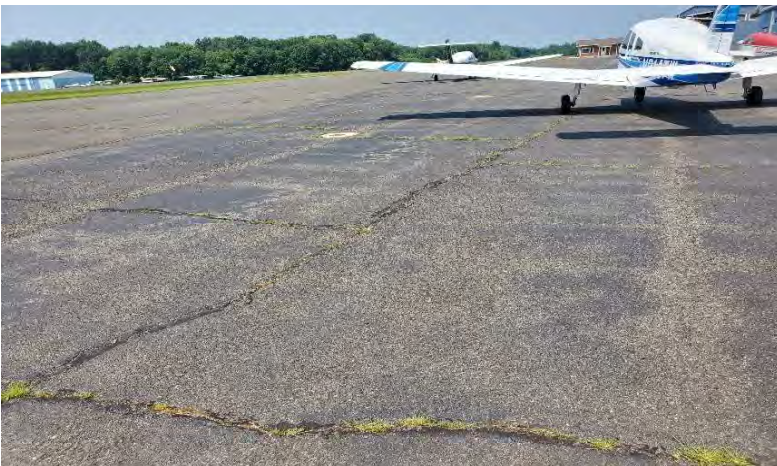
**Photo No: A-11**

Description: M-Block Cracking; M-Weathering

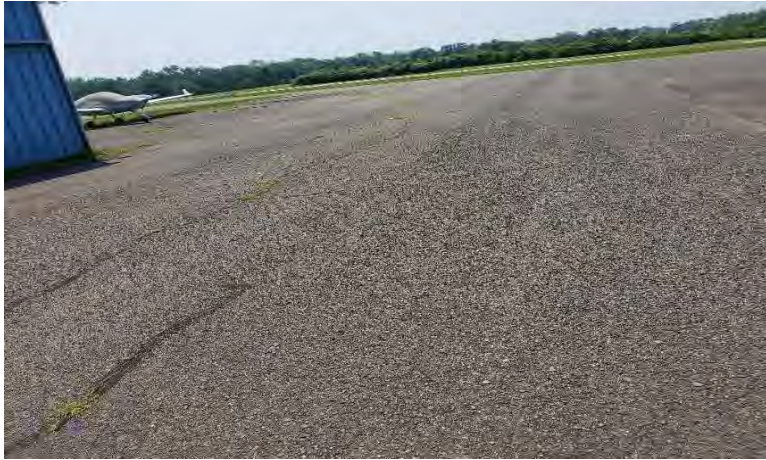
**Photo No: A-10**

Description: M-Longitudinal & Transverse Cracking; L-Weathering

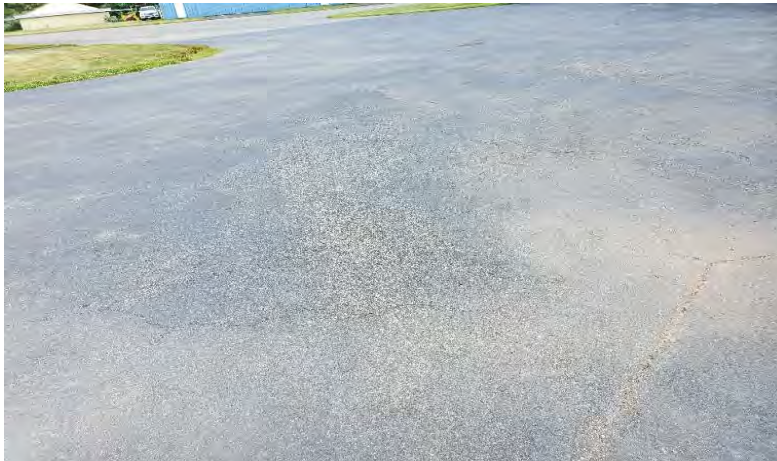
**Photo No: A-12**

Description: L-Depression; L/M-Longitudinal & Transverse Cracking; M-Fatigue Cracking; M-Weathering

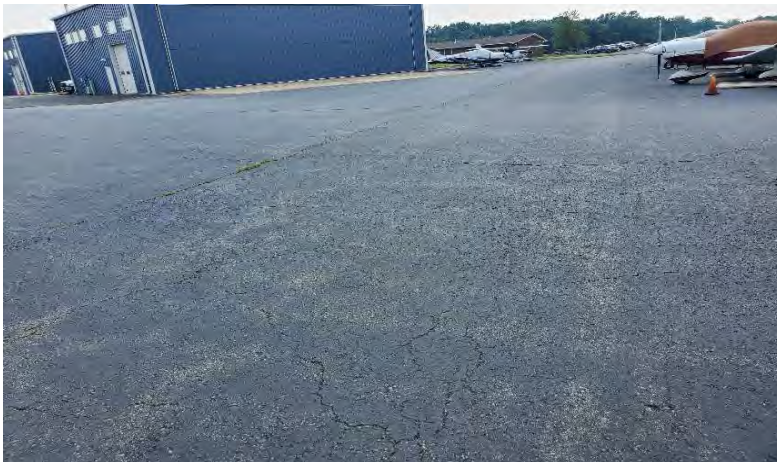
**Photo No: A-13**

Description: M-Fatigue Cracking; M-Block Cracking; M-Weathering
