**Advanced Infrastructure  
Design, Inc.**

# **2022 PAVEMENT CONDITION INDEX (PCI) REPORT**

**December 2023**

***Solberg-Hunterdon Airport (N51)  
Whitehouse Station, Hunterdon County, New Jersey***

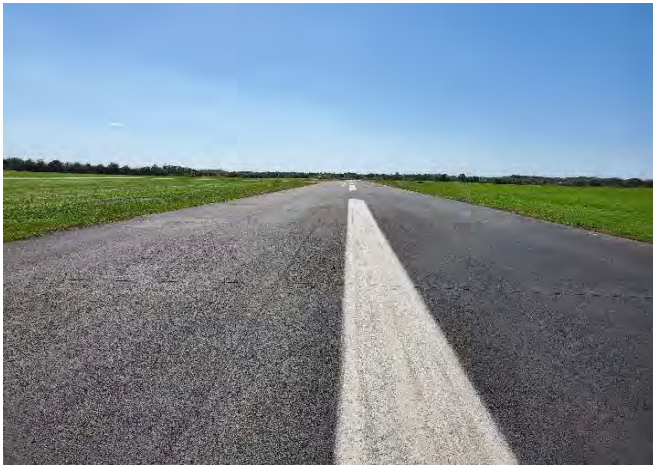
**Photo No: A-1**

Description: L-Longitudinal & Transverse Cracking

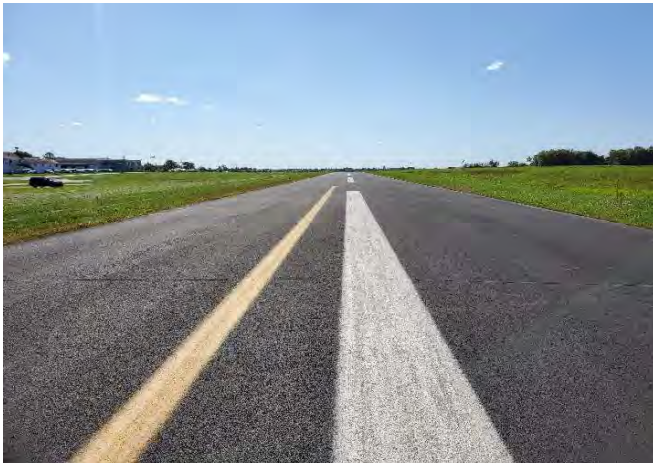
**Photo No: A-2**

Description: L-Longitudinal & Transverse Cracking

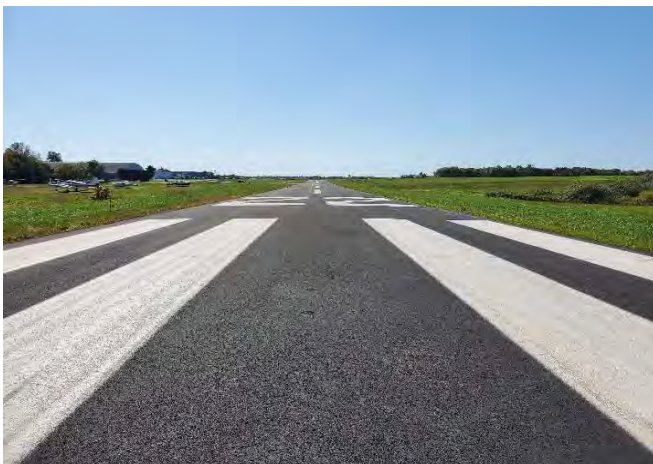
**Photo No: A-3**

Description: L-Longitudinal & Transverse Cracking; L-Patching

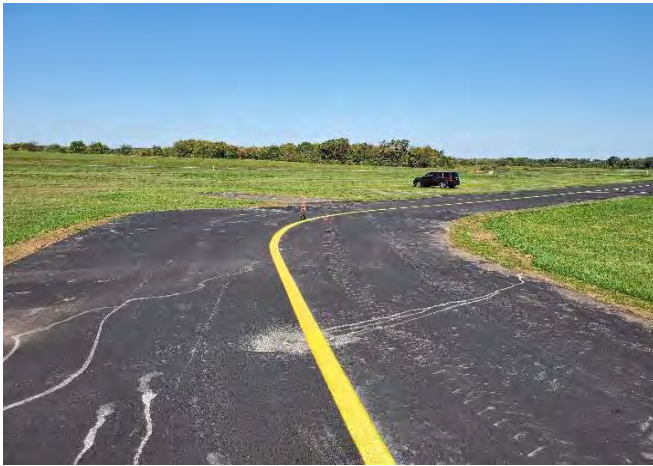
**Photo No: A-7**

Description: L-Patching (Core)

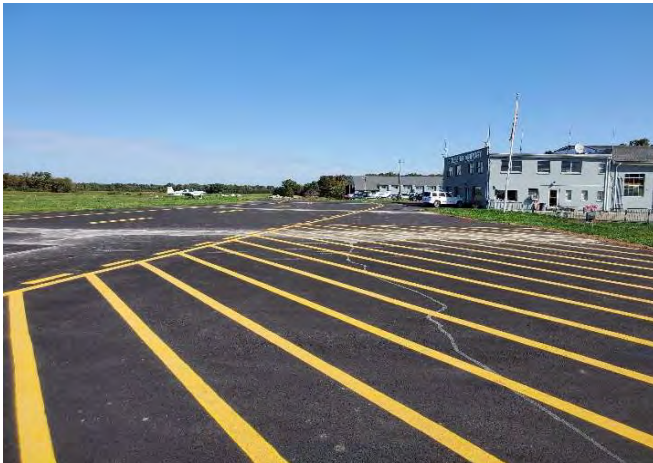
**Photo No: A-8**

Description: Minimal Distress

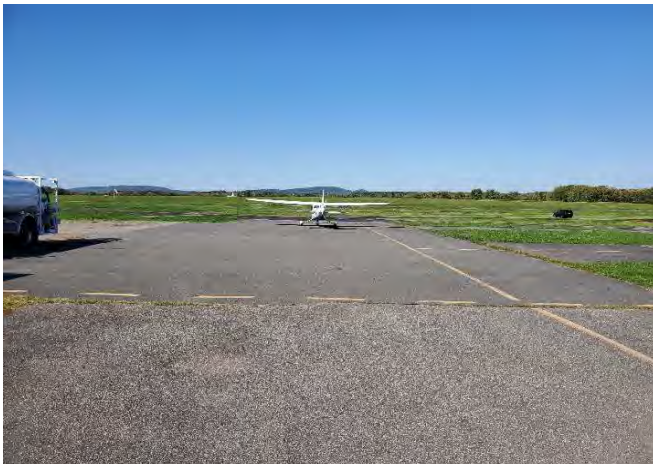
**Photo No: A-9**

| Branch ID | Section ID | PCI-2014 | | | | PCI-2022 | | | | Predominant distresses in 2022 |
|---|---|---|---|---|---|---|---|---|---|---|
| Apron 2 | 1 | 65 | Fair | 65 | Fair | 65 | Fair | 65 | Fair | Longitudinal and transverse cracking |

Description: M-Longitudinal & Transverse Cracking; L-Weathering

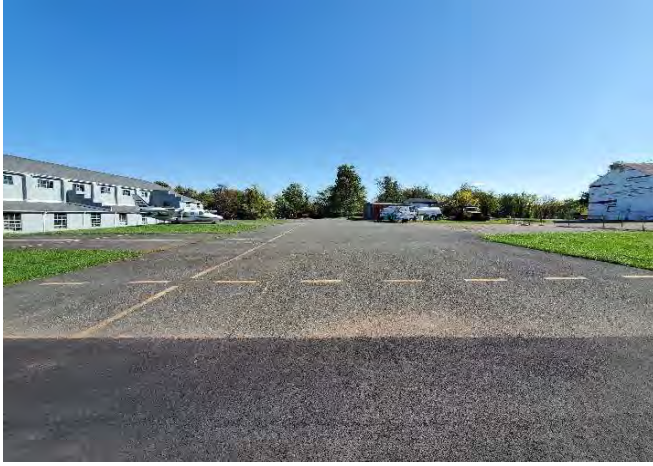
**Photo No: A-10**

Description: L/M-Longitudinal & Transverse Cracking; L-Weathering
