**Advanced Infrastructure  
Design, Inc.**

**2021/2023  
PAVEMENT CONDITION INDEX  
(PCI) REPORT**

**October 2023  
(Revised December 2023)**

***Greenwood Lake Airport (4N1)  
West Milford Township, Passaic County, New Jersey***

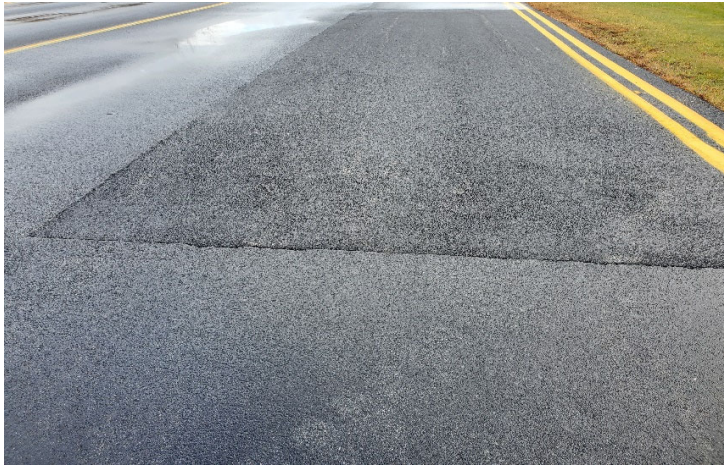
**Photo No: A-1**

Description: L-Patching

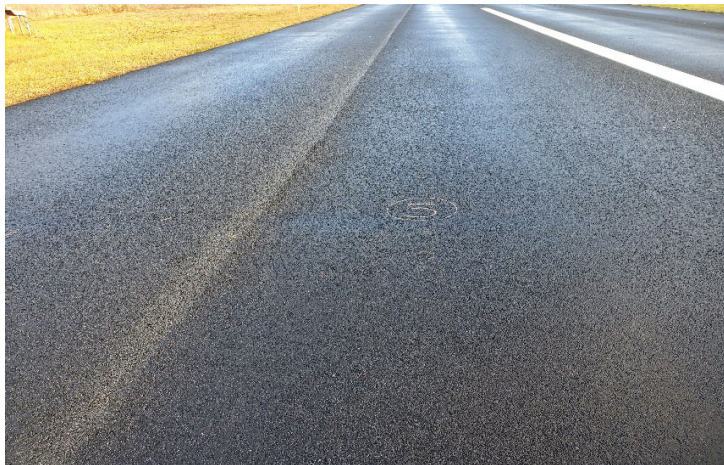
**Photo No: A-2**

Description: Minimal Distress

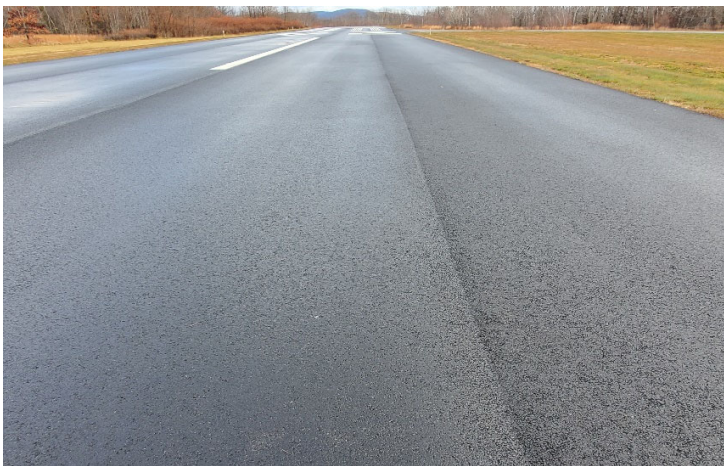
**Photo No: A-3**

Description: Minimal Distress

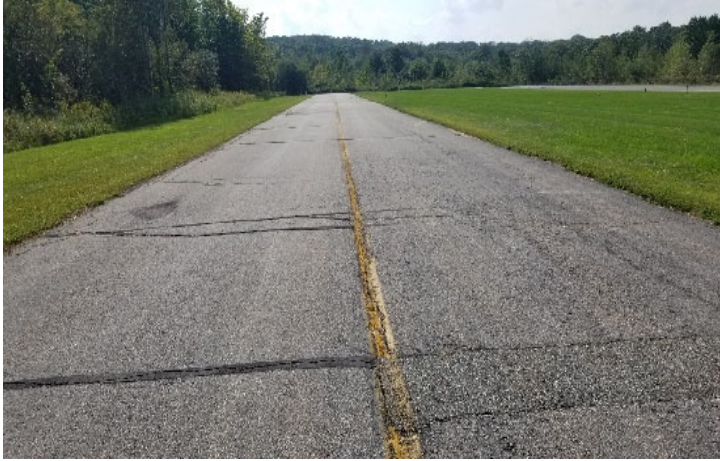
**Photo No: A-4**

Description: M-Longitudinal & Transverse Cracking; L-Patching; M-Weathering

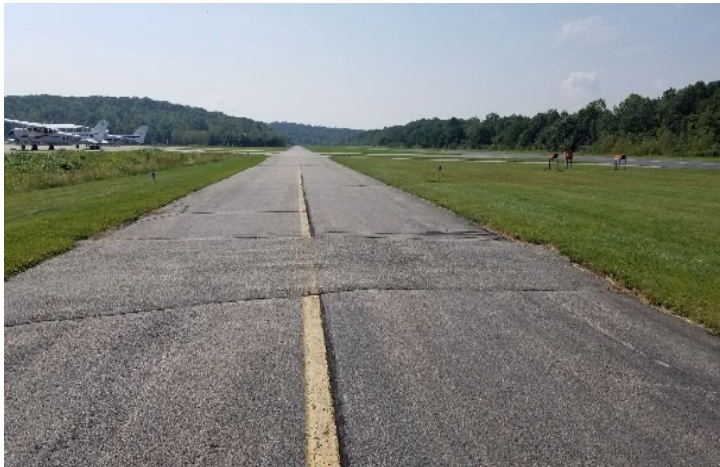
**Photo No: A-5**

Description: M-Longitudinal & Transverse Cracking; M-Patching; M-Weathering

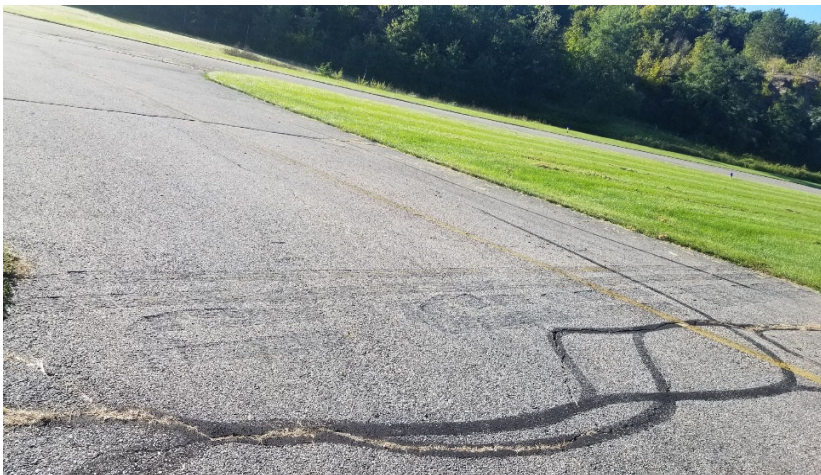
**Photo No: A-6**

Description: M/H-Longitudinal & Transverse Cracking; M/H-Weathering; M-Raveling

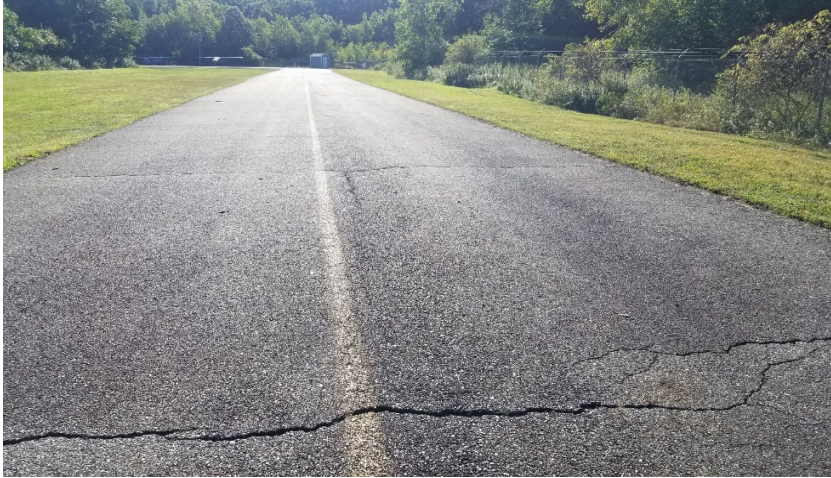
**Photo No: A-7**

Description: M/H-Longitudinal & Transverse Cracking; M-Weathering

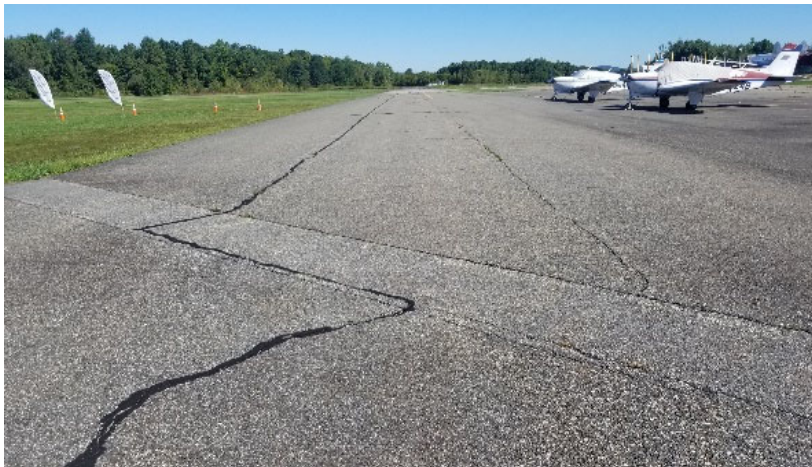
**Photo No: A-8**

Description: M-Patching; M/H-Longitudinal & Transverse Cracking; M/H-Weathering

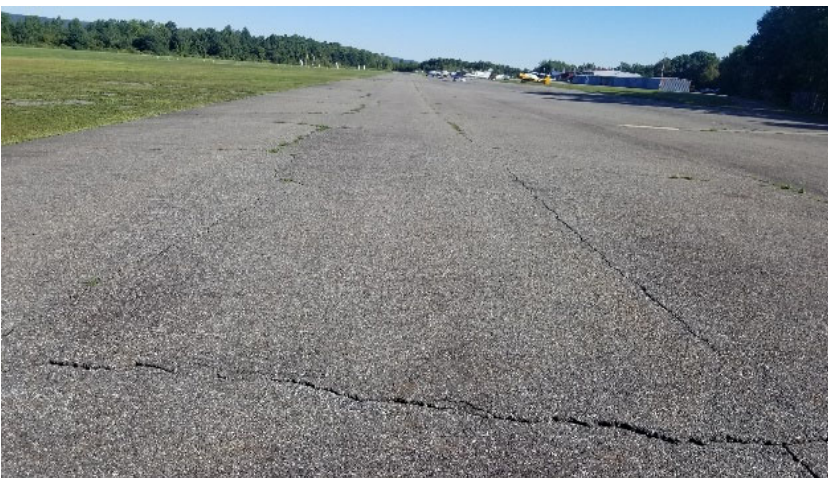
**Photo No: A-9**

Description: M/H-Longitudinal & Transverse Cracking; M/H-Weathering

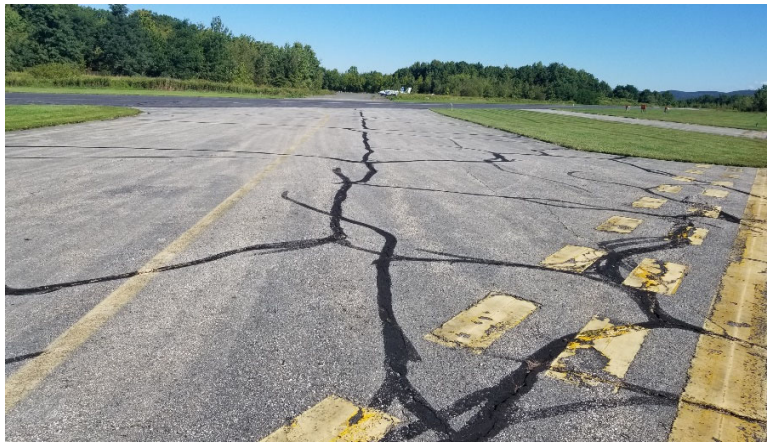
**Photo No: A-10**

Description: L/M-Longitudinal & Transverse Cracking; M/H-Weathering

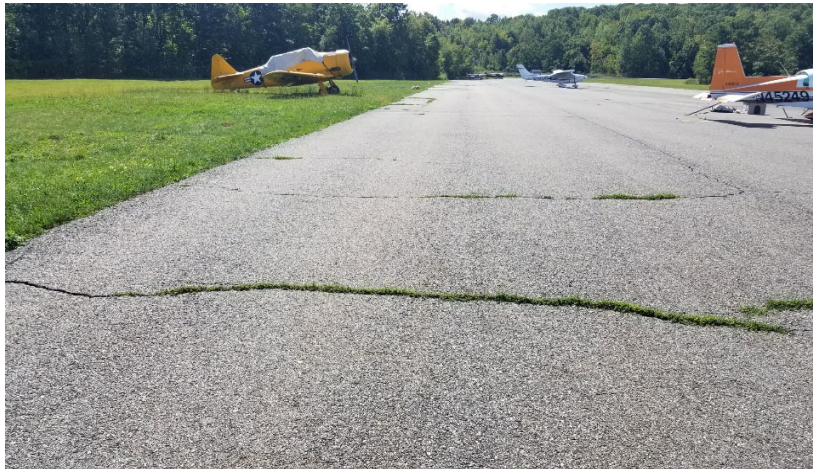
**Photo No: A-11**

Description: H-Longitudinal & Transverse Cracking; M/H-Weathering

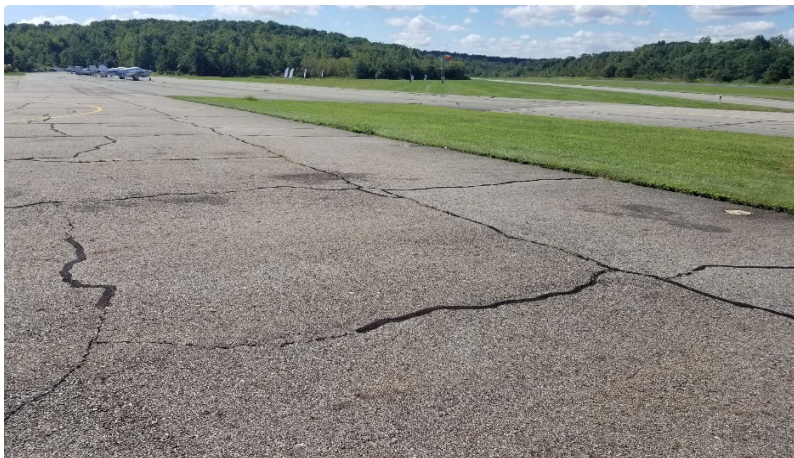
**Photo No: A-12**

Description: M-Longitudinal & Transverse Cracking; M/H-Weathering; Oil Spillage

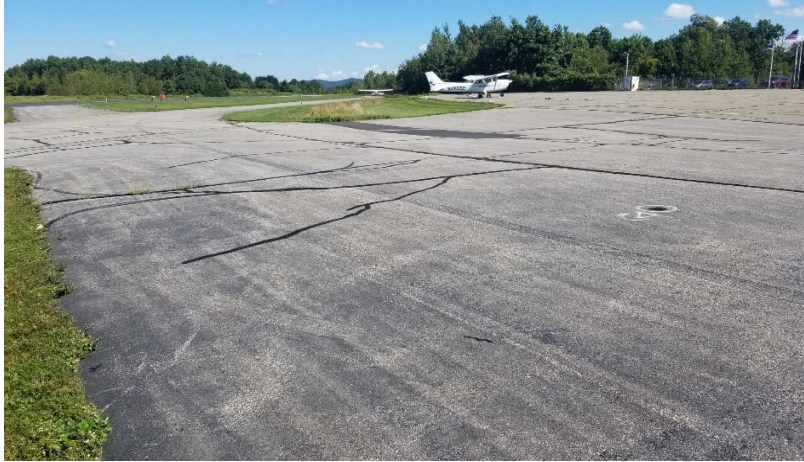
**Photo No: A-13**

Description: L-Patching; L/M-Longitudinal & Transverse Cracking; M/H-Weathering; M-Raveling

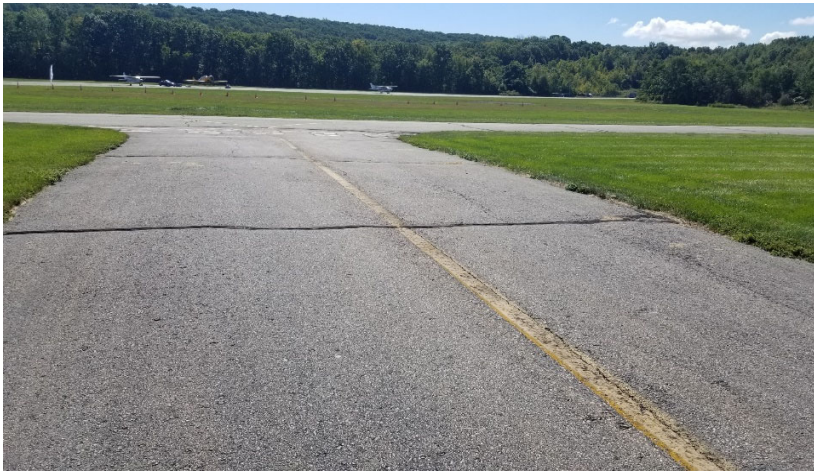
**Photo No: A-14**

Description: M-Raveling; M-Longitudinal & Transverse Cracking; M-Weathering

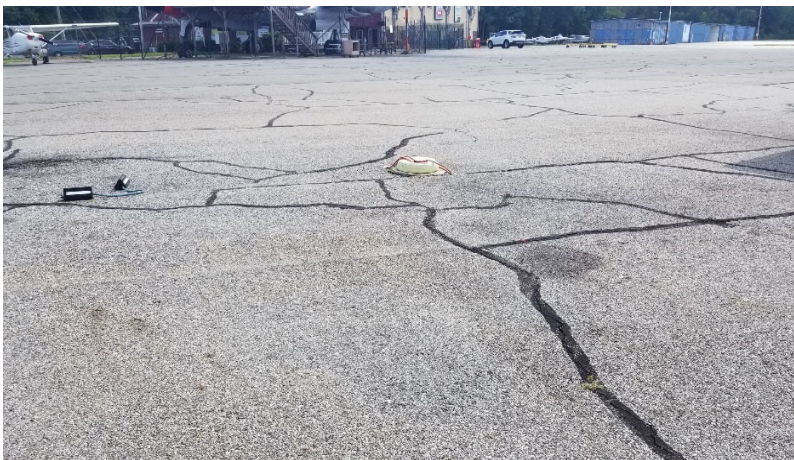
**Photo No: A-1**

Description: L/M-Block Cracking; Oil Spillage; M/H-Weathering; M-Raveling
