# **2021 PAVEMENT CONDITION INDEX (PCI) REPORT**

**Report Submitted to:  
Jacobs Engineering  
Group, Inc.**

**December 2023**

***Lincoln Park Airport (N07)  
Lincoln Park, Morris County, New Jersey***

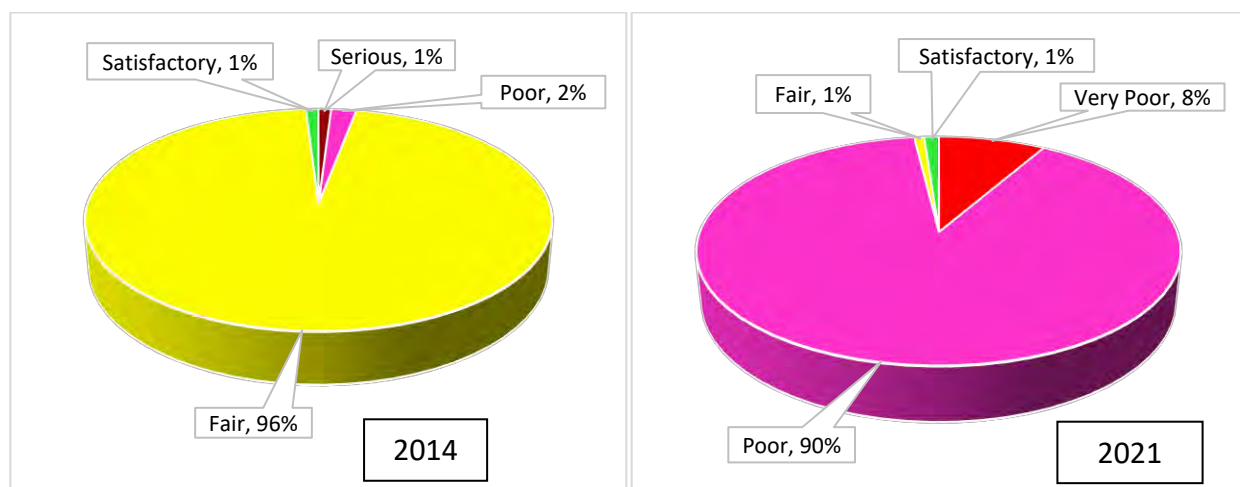
**Figure 1. Comparison of Overall N07 PCI Category Breakdown in 2014 and 2021.**

Based on the pavement distress survey and analysis, it was found that the runway, taxiway, and apron pavement of airport N07, considered as a whole, is currently in the POOR range with an overall average PCI of 49. This is a 13-point reduction from the overall PCI of 62 (FAIR) found for the airport in 2014. The percentage breakdowns of the pavement area falling within each PCI condition category, both in 2014 and 2021, are provided in Figure 1. This figure shows that the airport pavement was almost entirely in FAIR condition (96%) with the remaining area split between POOR (2%), SERIOUS (1%), and SATISFACTORY (1%) in 2014. But it deteriorated to being almost entirely in POOR condition (90%), with the remaining area split between VERY POOR (8%), FAIR (1%), and SATISFACTORY (1%) conditions in 2021.

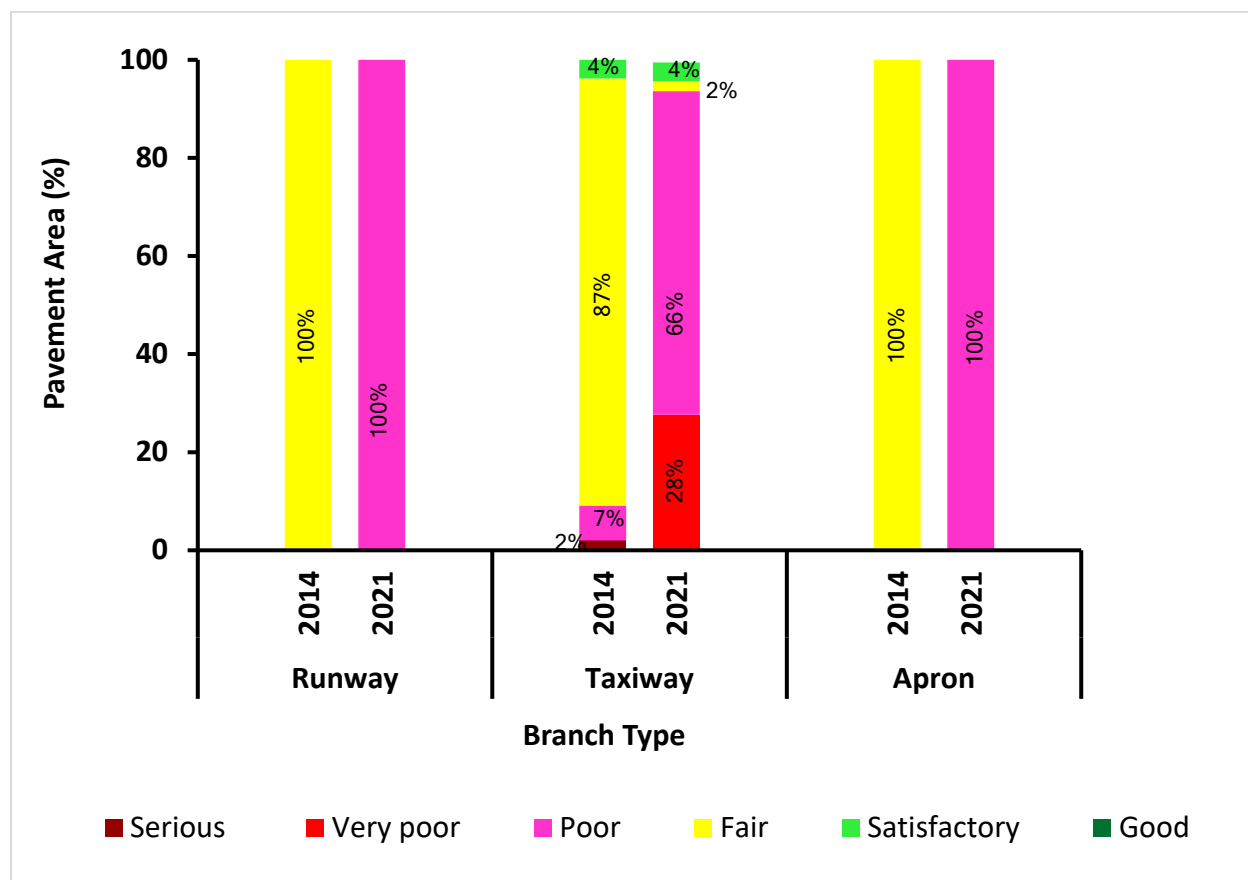
**Figure 2. Comparison of PCI Category Breakdown by Branch Use in 2014 and 2021.**

Figure 2 shows the PCI category breakdown by branch type in 2014 vs. 2021. The runway and apron, which were in FAIR condition in 2014, worsened to POOR condition in 2021. The taxiways, which were in majority FAIR condition (87%) in 2014, deteriorated to being mostly split between POOR (66%) and VERY POOR (28%) condition in 2021.

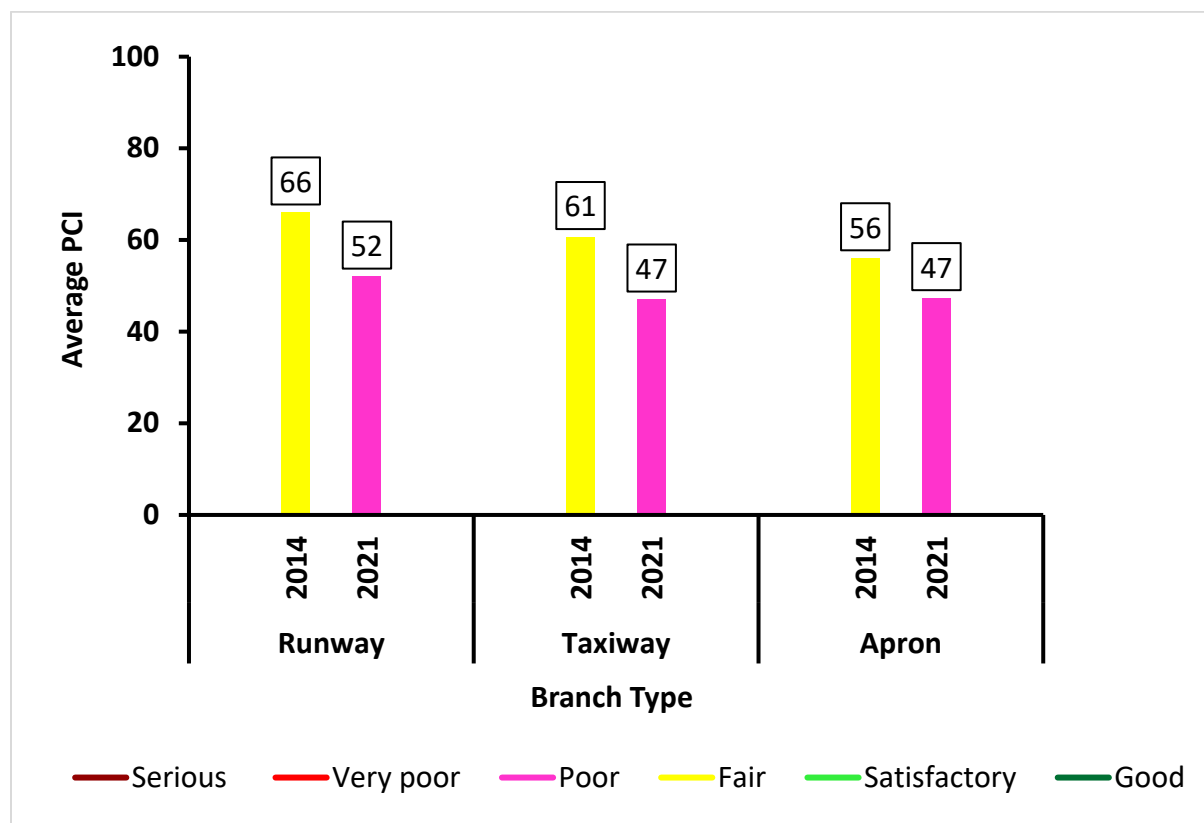
**Figure 3. Comparison of Average PCI by Branch Use in 2014 and 2021.**

Figure 3 shows the weighted average PCI change from 2014 to 2021 to visualize the rate of deterioration. The PCI deterioration rates for the runway, taxiway, and apron pavement were -2.0, -1.9, and -1.2 PCI points/year.
