**Advanced Infrastructure  
Design, Inc.**

**2021  
PAVEMENT CONDITION INDEX  
(PCI) REPORT**

**December 2023**

***Somerset Airport (SMQ)  
Bedminster Township, Somerset County, New Jersey***

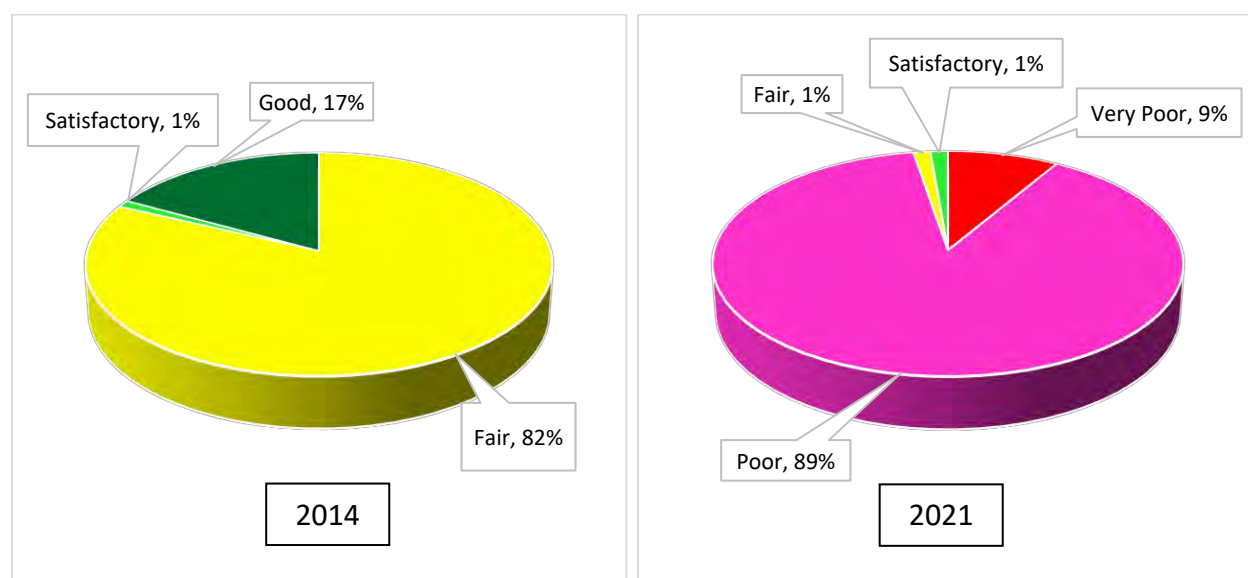
**Figure 1. Comparison of Overall SMQ PCI Category Breakdown in 2014 and 2021.**

Based on the pavement distress survey and analysis, it was found that the runway, taxiway, and apron pavement of airport SMQ, considered as a whole, is currently in POOR condition with an overall average PCI of 44. This is a 23-point reduction from the overall PCI of 67 (FAIR) found for the airport in 2014. The percentage breakdowns of the pavement area falling within each PCI condition category, both in 2014 and 2021, are provided in Figure 1. This figure shows that the airport pavement was in mostly FAIR condition (82%) with the remaining area in GOOD (17%) and SATISFACTORY (1%) conditions in 2014 but deteriorated to mostly POOR condition (89%) with the remaining area in VERY POOR (9%), FAIR (1%), and SATISFACTORY (1%) conditions in 2021.

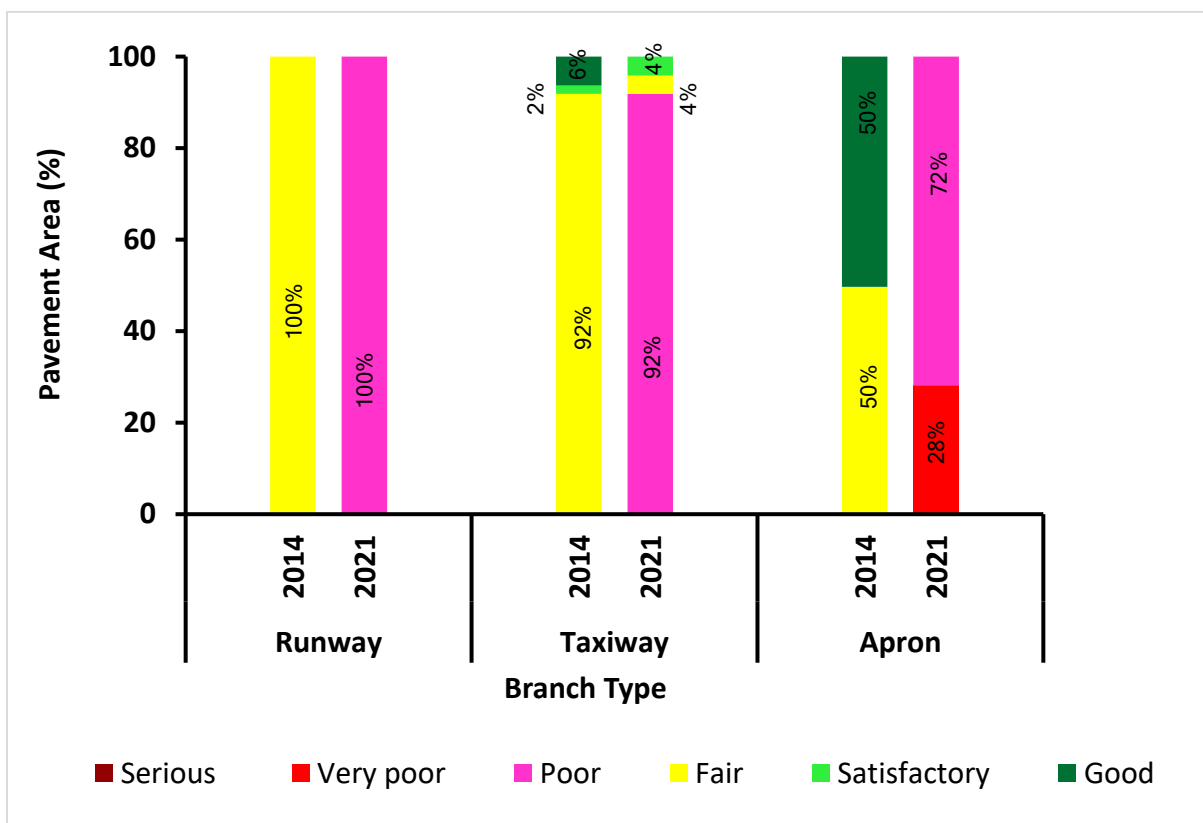
**Figure 2. Comparison of PCI Category Breakdown by Branch Use in 2014 and 2021.**

Figure 2 shows the PCI category breakdown by branch use in 2014 vs. 2021. The runway worsened from FAIR condition in 2014 to POOR condition in 2021. The taxiways, which were mostly in FAIR condition (92%) with the remaining area in GOOD (6%) and SATISFACTORY (2%) condition in 2014, became mostly POOR condition (92%) with the remainder evenly split between SATISFACTORY (4%), and FAIR (4%) condition in 2021. The aprons worsened from being evenly split between GOOD (50%) and FAIR (50%) condition in 2014 to mostly POOR condition (72%) with the remaining area (28%) in VERY POOR condition in 2021.

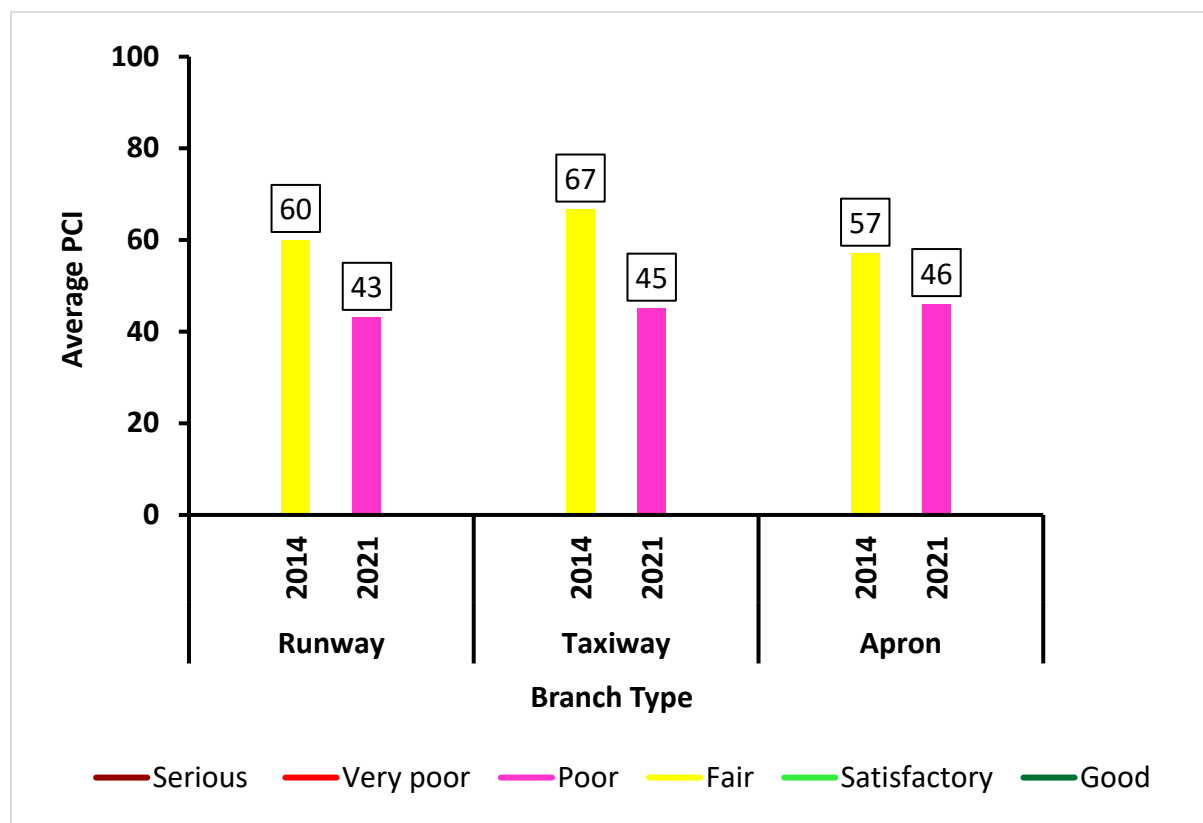
**Figure 3. Comparison of Average PCI by Branch Use in 2014 and 2021.**

Figure 3 shows the weighted average PCI change from 2014 to 2021 to visualize the rate of deterioration. The PCI deterioration rates from 2014 to 2021 for the runway, taxiway, and apron pavements were -2.4, -3.1, and -1.6 PCI points/year, respectively.
