**Advanced Infrastructure  
Design, Inc.**

# **2022 PAVEMENT CONDITION INDEX (PCI) REPORT**

**December 2023**

***Solberg-Hunterdon Airport (N51)  
Whitehouse Station, Hunterdon County, New Jersey***

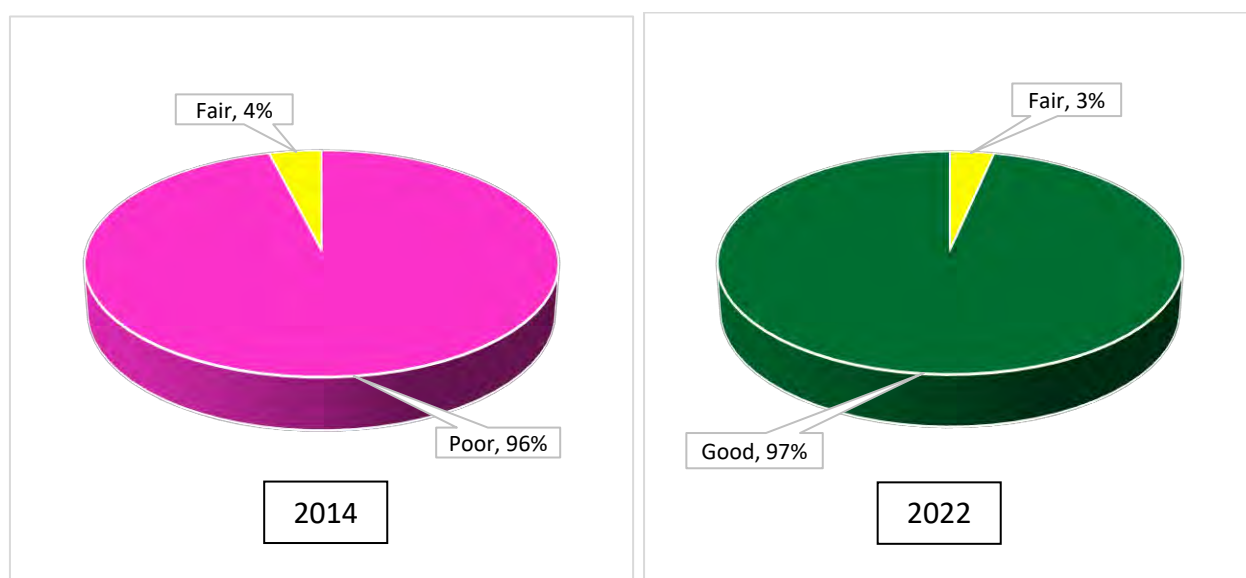
**Figure 1. Comparison of Overall N51 PCI Category Breakdown in 2014 and 2022.**

Based on the pavement distress survey and analysis, it was found that the runway, taxiway, and apron pavement of airport N51, considered as a whole, is currently in GOOD condition with an overall average PCI of 94. This is a 43-point increase from the overall PCI of 51 (POOR) found for the airport in 2014. This improvement in conditions can be attributed to the M&R activities that occurred in nearly all sections of the airport. The percentage breakdowns of the pavement area falling within each PCI condition category, both in 2014 and 2022, are shown in Figure 1. This figure shows that nearly all of the pavement areas were in POOR condition (96%) in 2014 but improved to nearly all of the pavement being in GOOD condition (97%) in 2022.

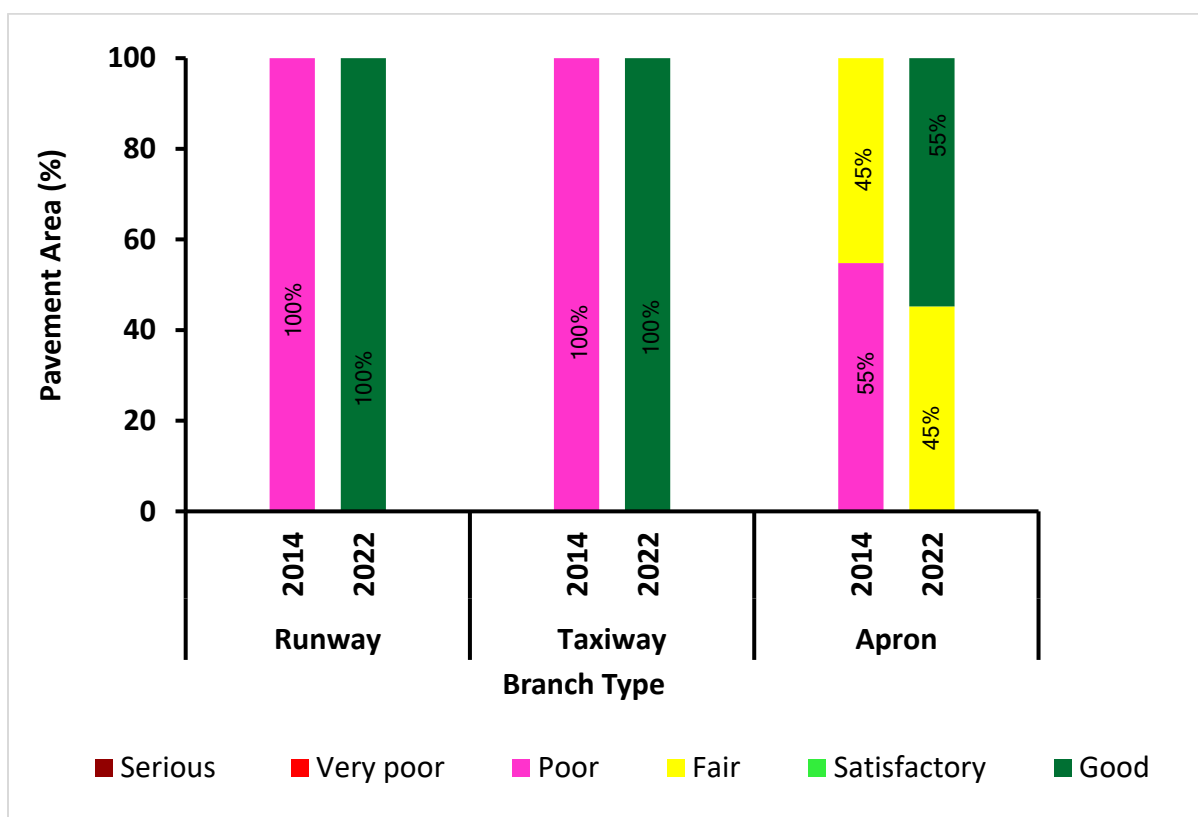
**Figure 2. Comparison of PCI Category Breakdown by Branch Use in 2014 and 2022.**

Figure 2 shows the PCI category breakdown by branch use in 2014 vs. 2022. The runway and taxiway improved from POOR condition in 2014 to GOOD condition in 2022. These increases in conditions are due to a new extension on Runway 4-22 as well as resurfacing projects on the runway and taxiway. Regarding the aprons, Apron 2 remained in FAIR condition while Apron 1 improved from POOR to GOOD condition due to an M&R activity on the pavement.

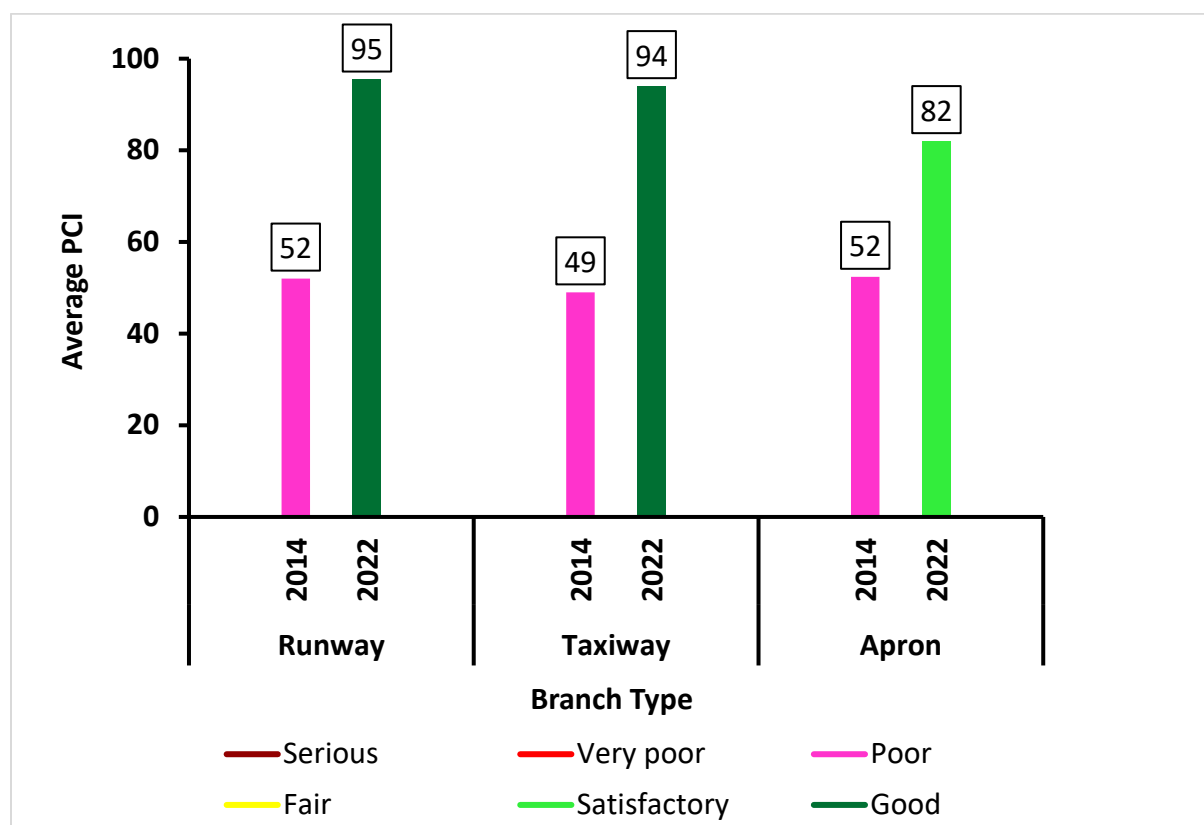
**Figure 3. Comparison of Average PCI by Branch Use in 2014 and 2022.**

Figure 3 shows the change in overall weighted average PCI by branch use. The PCI values improved from 2014 to 2022 due to the M&R activity that occurred in all branch types.
