**Advanced Infrastructure  
Design, Inc.**

**2021/2023  
PAVEMENT CONDITION INDEX  
(PCI) REPORT**

**October 2023  
(Revised December 2023)**

***Greenwood Lake Airport (4N1)  
West Milford Township, Passaic County, New Jersey***

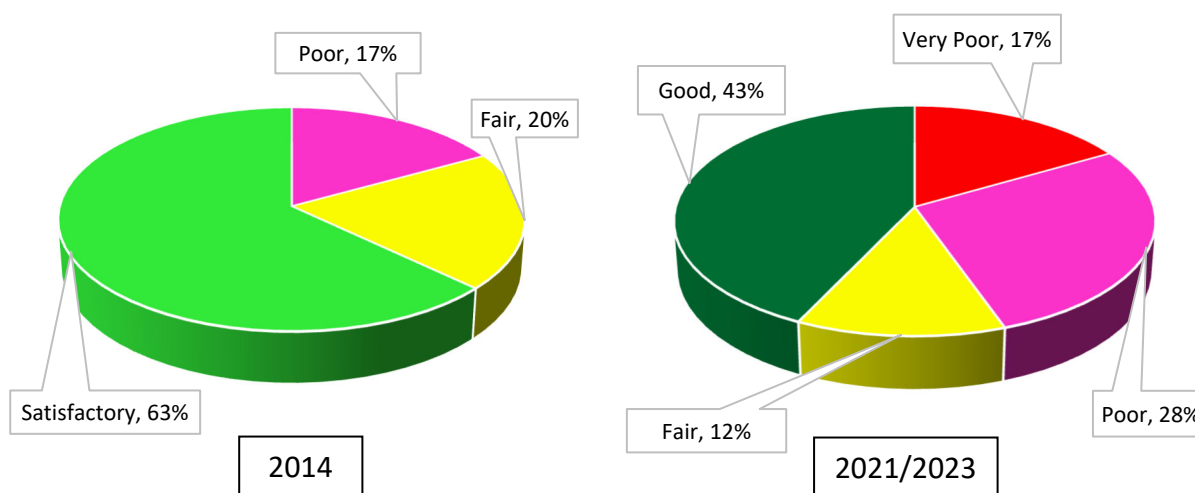
**Figure 1. Comparison of Overall 4N1 PCI Category Breakdown in 2014 and 2021/2023**

Based on the pavement distress survey and analysis, it was found that the runway, taxiway, and apron pavement of airport 4N1, considered as a whole, is currently in the SATISFACTORY range with an overall average PCI of 72. This is a 7-point increase from the overall PCI of 65 (FAIR) found for the airport in 2014. The percent breakdowns of the pavement area falling within each PCI condition category, both in 2014 and 2021/2023, are provided in Figure 1. This figure shows that the airport pavement was 63% SATISFACTORY (remainder split between FAIR and POOR) in 2014 but improved to 43% GOOD, 28% POOR, 17% VERY POOR, and 12% FAIR conditions in 2021/2023.

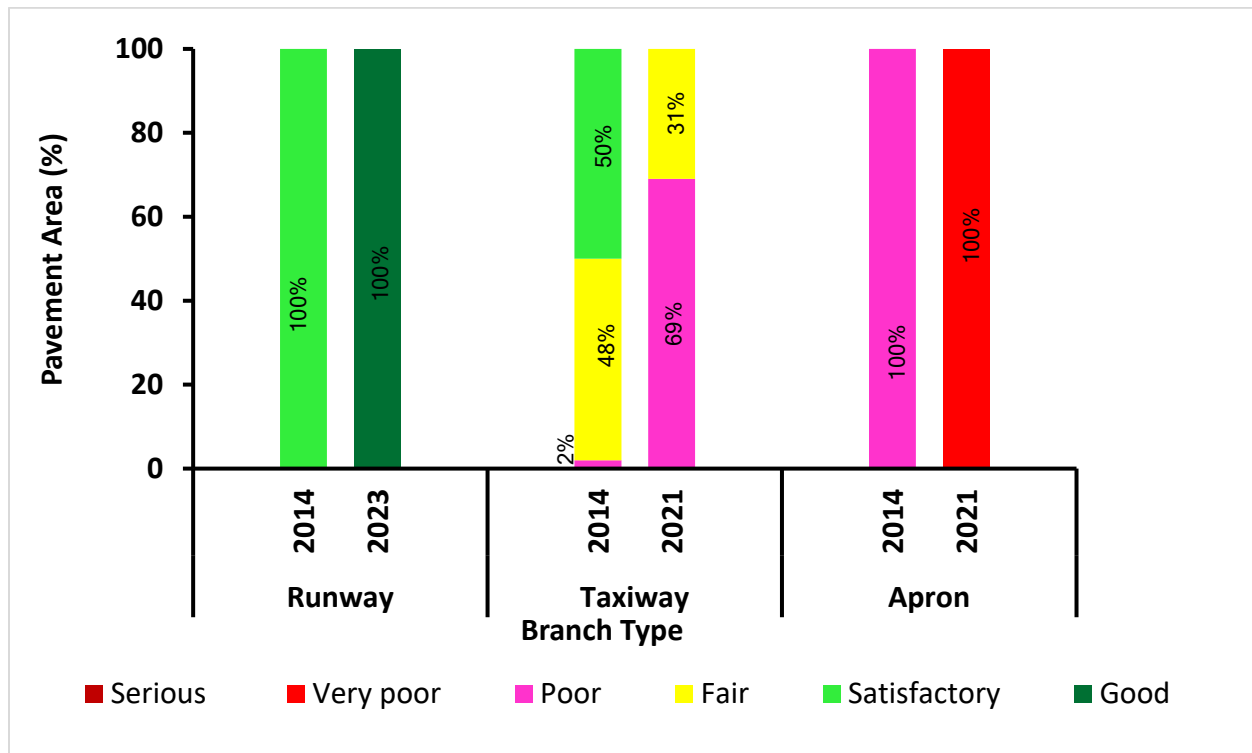
**Figure 2. Comparison of PCI Category Breakdown by Branch Use in 2014 and 2021/2023**

Figure 2 shows the PCI category breakdown by branch use in 2014 vs. 2021/2023. Runway 6-24 improved from SATISFACTORY condition in 2014 to GOOD condition in 2023. This improvement is due to the resurfacing operation conducted in October 2022. The taxiways, which were mostly evenly split between SATISFACTORY and FAIR conditions in 2014, became mostly (69%) POOR with the remainder (31%) in FAIR condition in 2021. The apron worsened from POOR condition in 2014 to VERY POOR condition in 2021. It should be noted that a minor M&R activity (limited patching) was reported to have been completed in 2017.

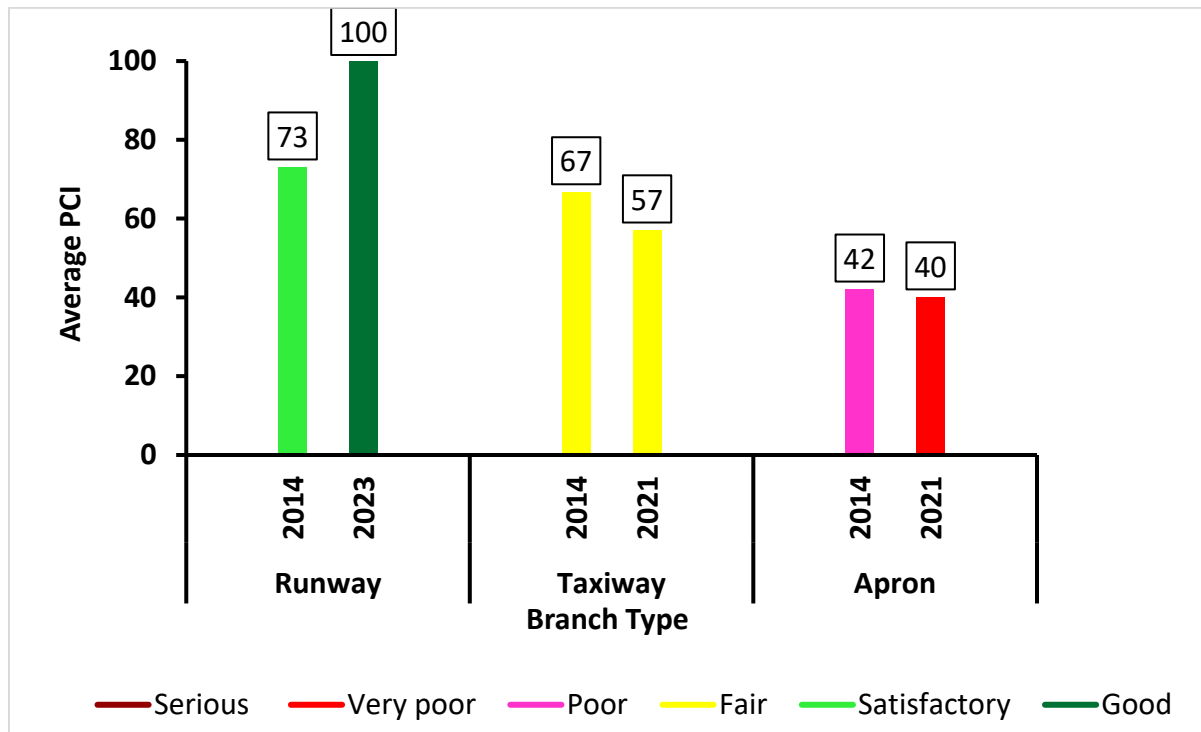
**Figure 3. Comparison of Average PCI by Branch Use in 2014 and 2021/2023**

Figure 3 shows the weighted average PCI change from 2014 to 2021/2023 to visualize the rate of deterioration. As noted before, the improvement in PCI in the runway is due to M&R activity performed, thus the PCI deterioration rate is invalid. The PCI deterioration rate of the taxiways was -1.4 PCI points/year. The PCI deterioration rate of the apron is also invalid due to minor M&R activity which occurred.
